# TMS320F28P55x Real-Time MCUs Silicon Errata

## Silicon Revisions A, 0

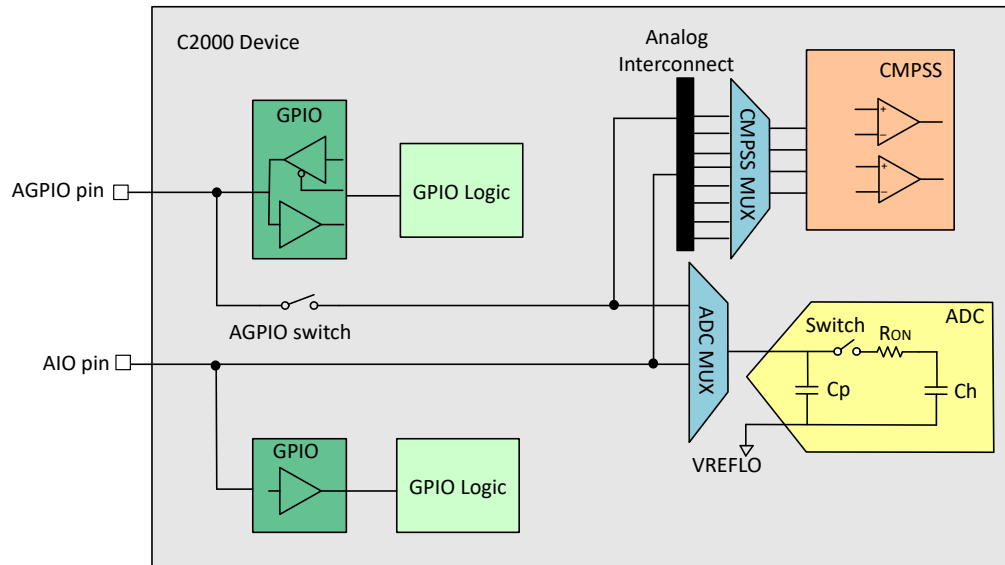
**Figure 3-1. Analog Subsystem Diagram with AGPIO and AIO Analog Pin Types**
**Workarounds**

The AGPIO analog pin path contains an extra series switch of 53Ω. This creates a low-capacitance isolated node shared by the ADC and CMPSS comparator, as shown in [Figure 3-1](#). This node can be disturbed when the ADC samples the channel (depending on the prior voltage stored on the ADC sample-and-hold capacitor), and this disturbance can cause a false CMPSS event of up to 50ns. To accommodate this potential disturbance, the workarounds below can be implemented.

1. Use a different pin (that is AIO pin type) for analog channels that need both ADC and CMPSS together.
2. Use the CMPSS Digital Filter with a setting of 50ns or greater, which will filter the temporary disturbance.
3. Pre-condition the sample-and-hold capacitor of the ADC so that the disturbance will not cause a false trip. For example, perform a dummy read of a 3.3V connection from a different channel on the ADC immediately before the impacted channel is read, so the disturbance is in the positive direction, away from the false trip. The opposite dummy read of a 0V signal would be used if the false trip is inverted in polarity.

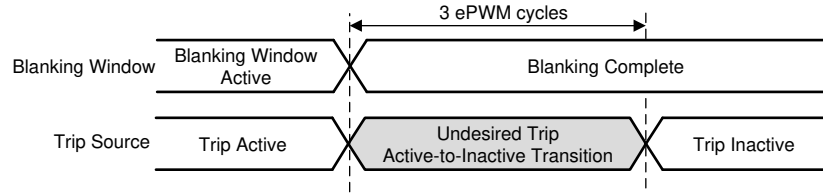
**Figure 3-2. Undesired Trip Event and Blanking Window Expiration**

The blanking window is typically used to mask any PWM trip events during transitions which would be false trips to the system. If an ePWM trip event remains active for less than three ePWM clocks after the end of the blanking window cycles, there can be an undesired glitch at the ePWM output.

Figure 3-2 illustrates the time period which could result in an undesired ePWM output.

Extend or reduce the blanking window to avoid any undesired trip action.
