TMS320F28P55x Real-Time MCUs Silicon Errata

Silicon Revision 0

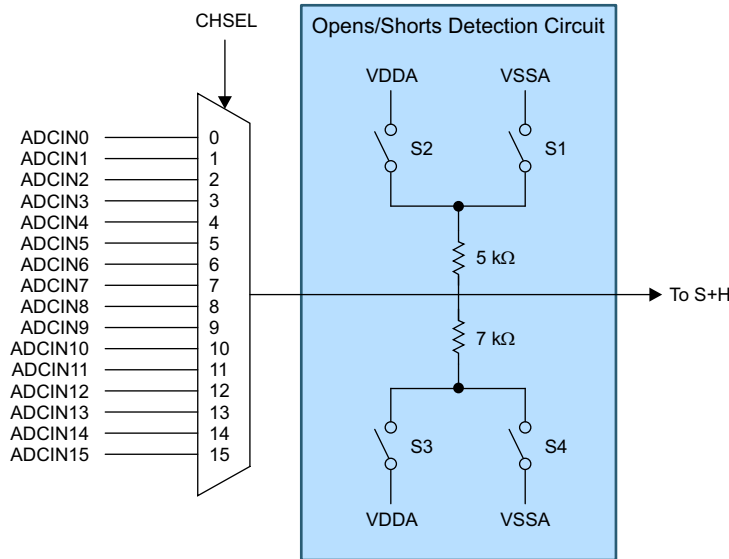
The OSDETECT register has been removed from the ADC chapter and registers section of the *TMS320F28P55x Real-Time Microcontrollers Technical Reference Manual*. This feature is not present in revision 0 silicon.

The control registers have been removed in revision 0 silicon. This circuit is not present.
