Table of Contents

1 Introduction

This document describes the known exceptions to the functional and performance specifications to TI CMOS Radar Devices (AWRL6432AOP)

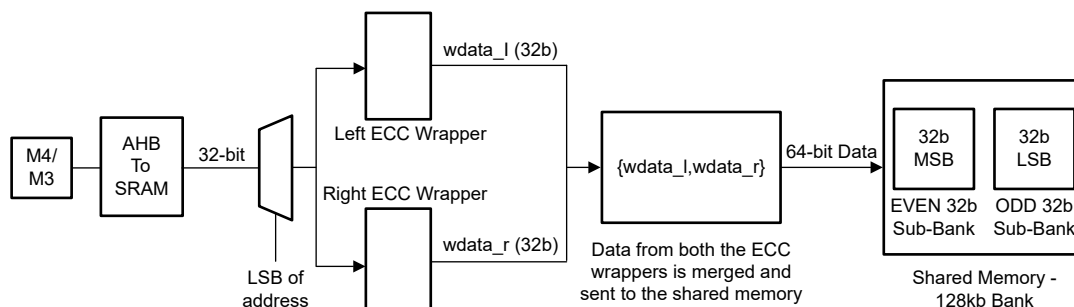
Figure 5-1. Shared Memory Logic Diagram When Shared with M4/M3

Internal shared memory has ODD and EVEN banking structure. For a particular address range, partial write (less than 32 bit) to EVEN bank corrupts same address of ODD bank with next data on the bus. When shared memory is allocated to M4/M3, back to back full word write access to location A followed by sub-word write access to location B corrupts data in location A.

When memory is shared with M4/M3, issue is seen in the following address range:

Memory	Address Range
APP_CPU_SHARED_RAM	0x0048 0000 - 0x004B FFFC
FEC_CPU_SHARED_RAM	0x2120 8000 - 0x2121 FFFC

When shared with M3/M4, the incoming data bit width is 32 bit as shown in the diagram. So, depending on LSB of address, signals are sent to either left or right ECC wrapper.

1. Use shared memories as code memory when shared with processor.
2. Disable ECC for non functional safety devices – ECC is disabled for shared memories in RBL for non functional safety devices.
