## ABSTRACT

This document describes the known exceptions to the functional specifications (advisories).

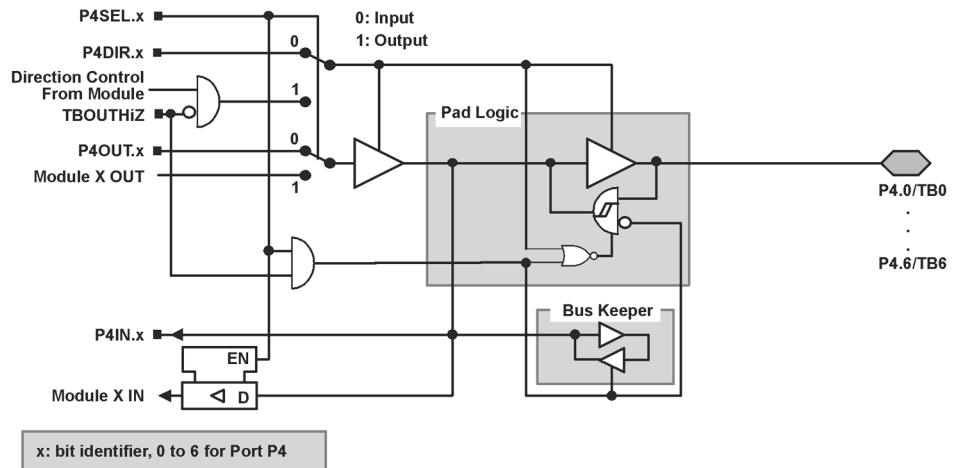
Port function as specified

Incorrect 3-state function of Ports P4.0/TB0 through P4.6/TB6 (TBoutHiZ control). If TBoutHiZ is set to high, all ports P4.0/TB0 through P4.6/TB6 are set to 3-state, independent of the P4SEL.x control signals. This means a port P4.x is switched to 3-state with TBoutHiZ, even if it is not selected for Timer\_B function. In addition, the ports P4.0/TB0 through P4.6/TB6 are switched to 3-state with TBoutHiZ, even if the port direction (direction control from module) is set to input. This is in accordance with the specification description but, nevertheless, is an unexpected behavior.

No workaround.
