ABSTRACT

This document describes the known exceptions to the functional specifications (advisories).

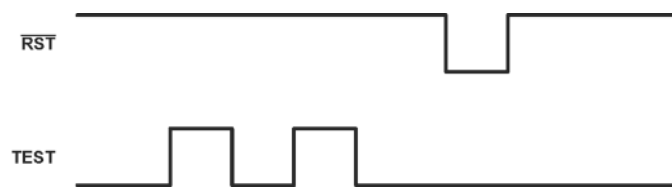
- Toggle the TEST pin twice when nRST is high and after 50us pull nRST low.

Note: This toggling of TEST pins is not subject to timing constraints. The appropriate level transitions on TEST pin, followed by a RST pulse after 50us, are sufficient to trigger an exit from BSL mode.

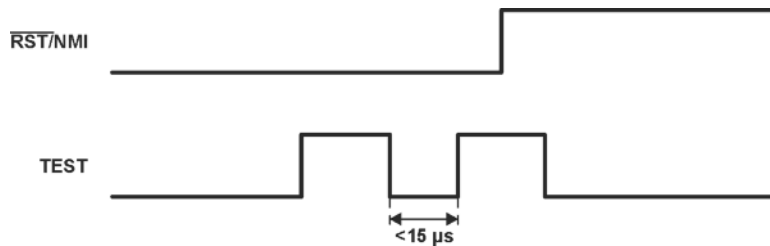
SYS10 *SYS Module*

Category	Functional
Function	BSL entry sequence is subject to specific timing requirements
Description	The BSL entry sequence requires that the low phase of the TEST/SBWTCK pin does not exceed 15us. This timing requirement is faster than most PC serial ports can provide, as shown in the following picture. If this requirement is not met, the entry sequence fails and the SYSBSLIND is not set.

Workaround An external hardware solution is recommended to provide the appropriate BSL entry sequence. See [http://processors.wiki.ti.com/index.php/BSL_\(MSP430\)](http://processors.wiki.ti.com/index.php/BSL_(MSP430)) for recommendations on available BSL hardware.
