Errata
MSP430F5338 Microcontroller

ABSTRACT

This document describes the known exceptions to the functional specifications (advisories).

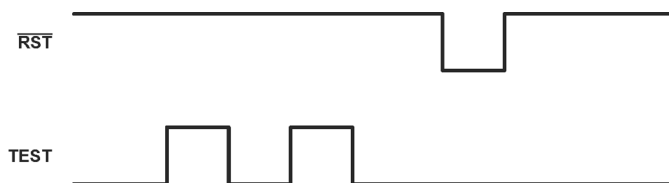
JTAG20	JTAG Module
Category	Software in ROM
Function	BSL does not exit to application code
Description	The methods used to exit the BSL per MSP430 Programming Via the Bootstrap Loader (SLAU319) are invalid.
Workaround	To exit the BSL one of the following methods must be used. <ul style="list-style-type: none"> - A Power cycle or <ul style="list-style-type: none"> - Toggle the TEST pin twice when nRST is high and after 50us pull nRST low.

Note: This toggling of TEST pins is not subject to timing constraints. The appropriate level transitions on TEST pin, followed by a RST pulse after 50us, are sufficient to trigger an exit from BSL mode.
