*RM57Lx Microcontroller*

**Silicon Revision B**

# **Silicon Errata**

Literature Number: SPNZ233B  
August 2015–Revised June 2018

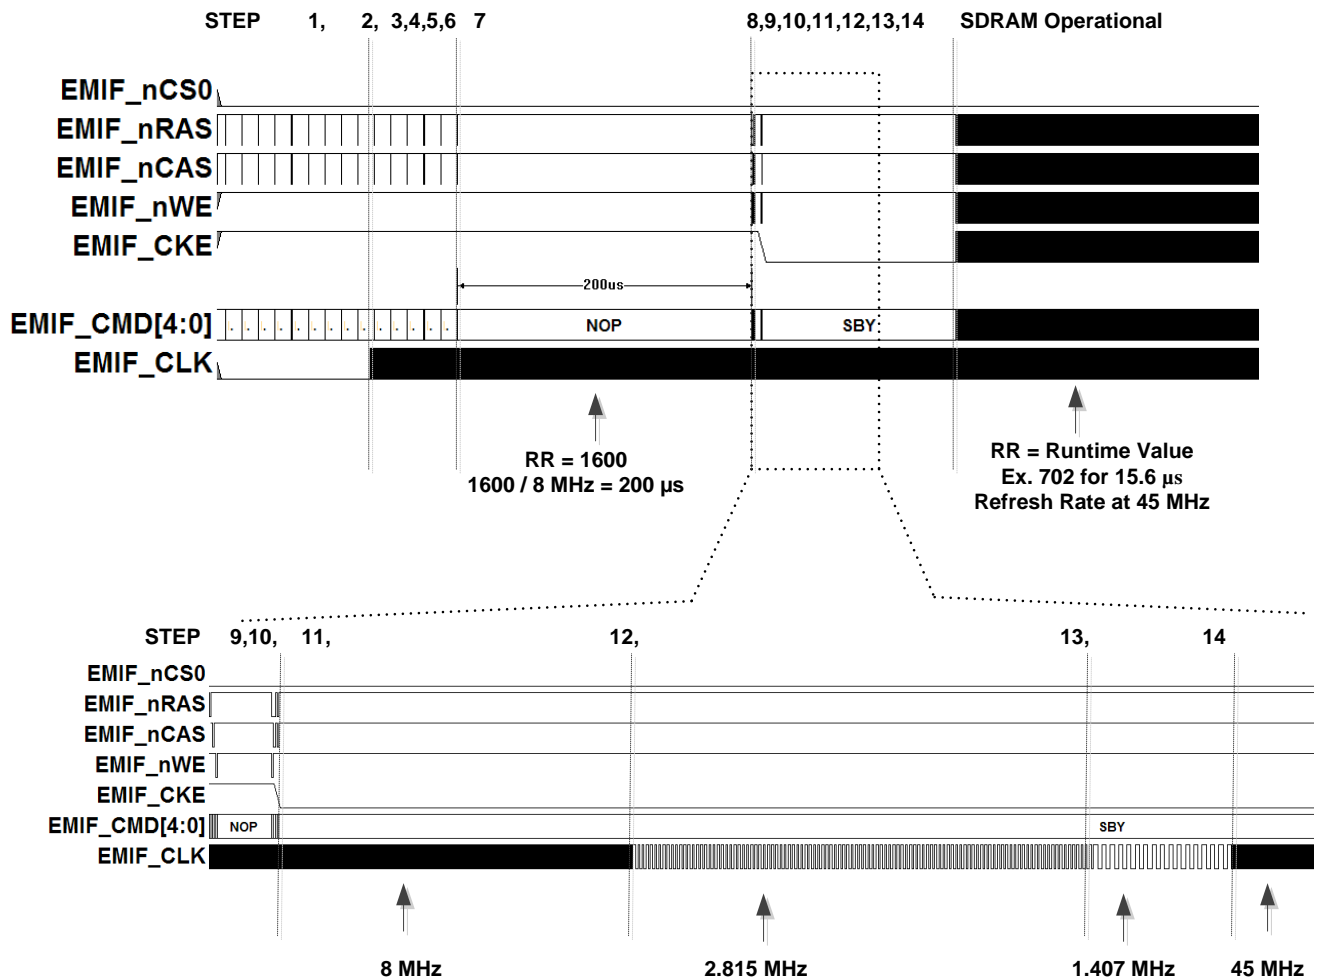
Figure 4. Correct SDRAM Initialization Procedure for Final EMIF Clock Frequency  $\geq 40$  MHz

<b>Issue</b>	Instead of issuing $8*RR$ NOP commands during initialization, the EMIF SDRAM controller only issues $1*RR$ NOP commands.
<b>Conditions</b>	This problem is a fundamental limitation in the EMIF module.
<b>Implications</b>	<p>The impact is dependent on the particular SDRAM device that is being used with the EMIF module. In many cases there will be no apparent issue even when the SDRAM specification is violated. Therefore, check and, if necessary, correct this problem even if no SDRAM-related issues have been observed.</p> <p>There are two possible implications to the delay of <math>1*RR</math> instead of <math>8*RR</math>:</p> <ul style="list-style-type: none"> <li>• For systems operating with an EMIF clock frequency &lt; 40 MHz, the RR counter value computed by software may be too small if the calculation was originally based on an <math>8*RR</math> EMIF clock cycle delay.</li> <li>• For systems operating with an EMIF clock frequency <math>\geq</math> 40 MHz, the RR counter value does not have the range necessary to create a 200-<math>\mu</math>s delay.</li> </ul>

[Figure 4](#) shows EMIF activity as the preceding device initialization sequence is performed, assuming an OSCIN frequency of 16.0 MHz and a PLL frequency of 180 MHz.
