TMS320C6472

Digital Signal Processor

Silicon Revisions 2.1, 1.2, 1.1, 1.0

Silicon Errata

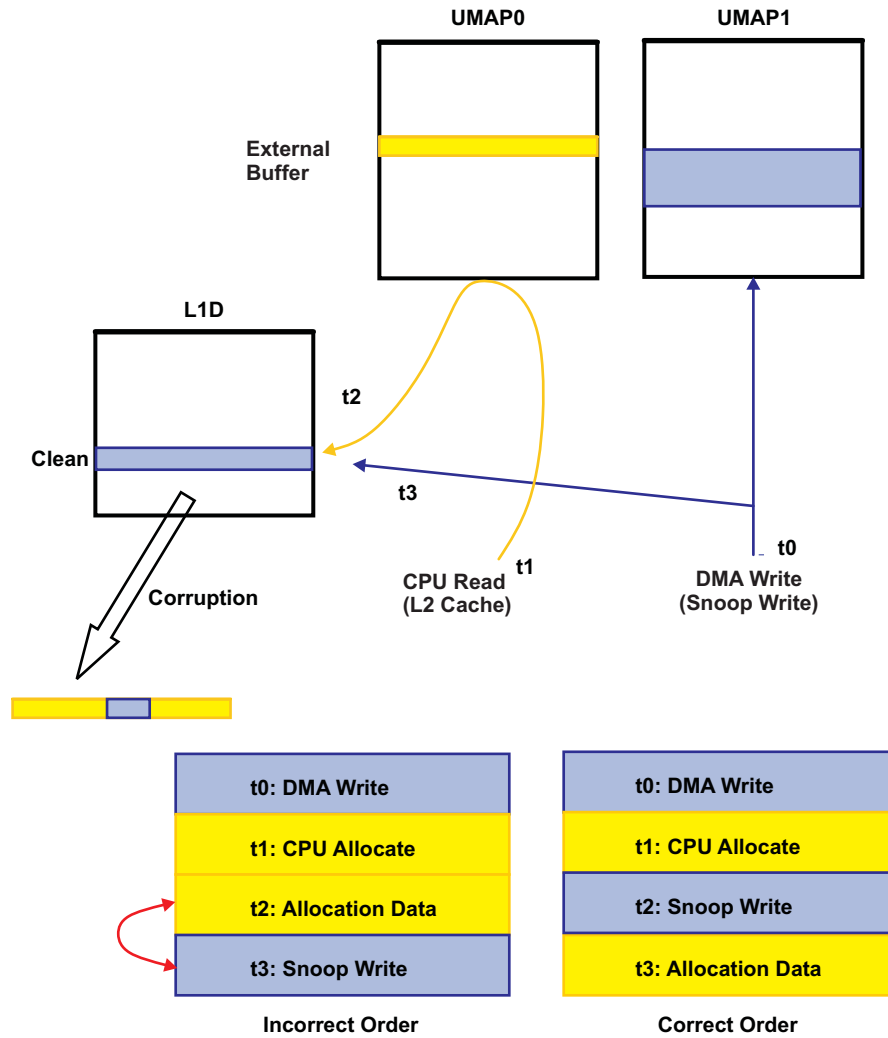
Figure 3. Cache Line Operations Flow

One can identify this issue unambiguously by examining the corrupted memory range in CCStudio using the cache tag viewer. The corrupted data shows up in the include L1D view in a memory window, but not in the exclude L1D view. The cache tag viewer should indicate that the line is also "clean" and the corrupt data should also be visible in its intended destination, which must be in UMAP1 and map to the same L1D set as the corrupted line.

Figure 3 shows the flow of these operations, the incorrect order that causes the issue, and the correct order. The blue line is Cache Line A and the yellow line is Cache line B.

In the description above, all of the conditions must be true for the issue to occur. Our workarounds essentially focus on picking one of the conditions and removing it so that you do not need to worry about the other conditions.

To prevent this sort of race condition, programs should discard inbound DMA buffers in UMAP1 immediately after use and keep a strict policy of "buffer ownership" such that a given buffer is owned only by the CPU or the DMA at any given time.

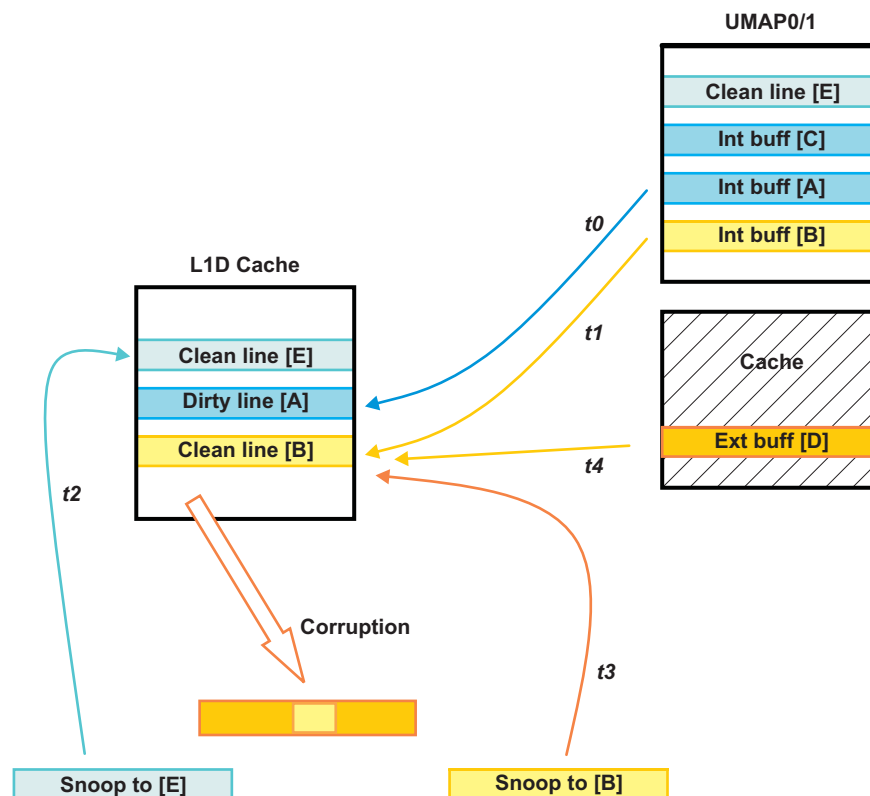
Figure 5. Sequence of Events

- (A) The snoop-write to Cache Line E, from Step 1 above, is now in process and blocking the snoop-write to Cache Line B from Step 2.
- (B) While Step A is going on, Cache Line A has either now been evicted and/or replaced by Cache Line C from Step 4 above and Cache Line B (the intended target of the delayed snoop-write) is now replaced with Cache Line D from Step 3 above.
- (C) Once the first snoop-write from operation C1 completes, the second (delayed) snoop-write mentioned in Step A to Cache Line B should be killed since Cache Line B was replaced in the operation in Step B. Instead, it is not killed and the line cached (which is now actually Cache Line D) is now updated incorrectly.

1. Cache Line D now holds data that was corrupted by the operation in Step C above (as a result of Step 2 above).
 - A subsequent read of this data returns a corrupted value.
 - Subsequent writes to this cache line also cause the corrupted values to be committed to lower levels of memory.

Figure 5 shows the sequence of events.

A compiler flag (`--c64p_dma_l1d_workaround`) has been added to the latest Code Generation Tools to resolve this potential issue. This flag can be utilized for all code in the system or used on particular files/functions that may be susceptible to the conditions listed in this advisory.

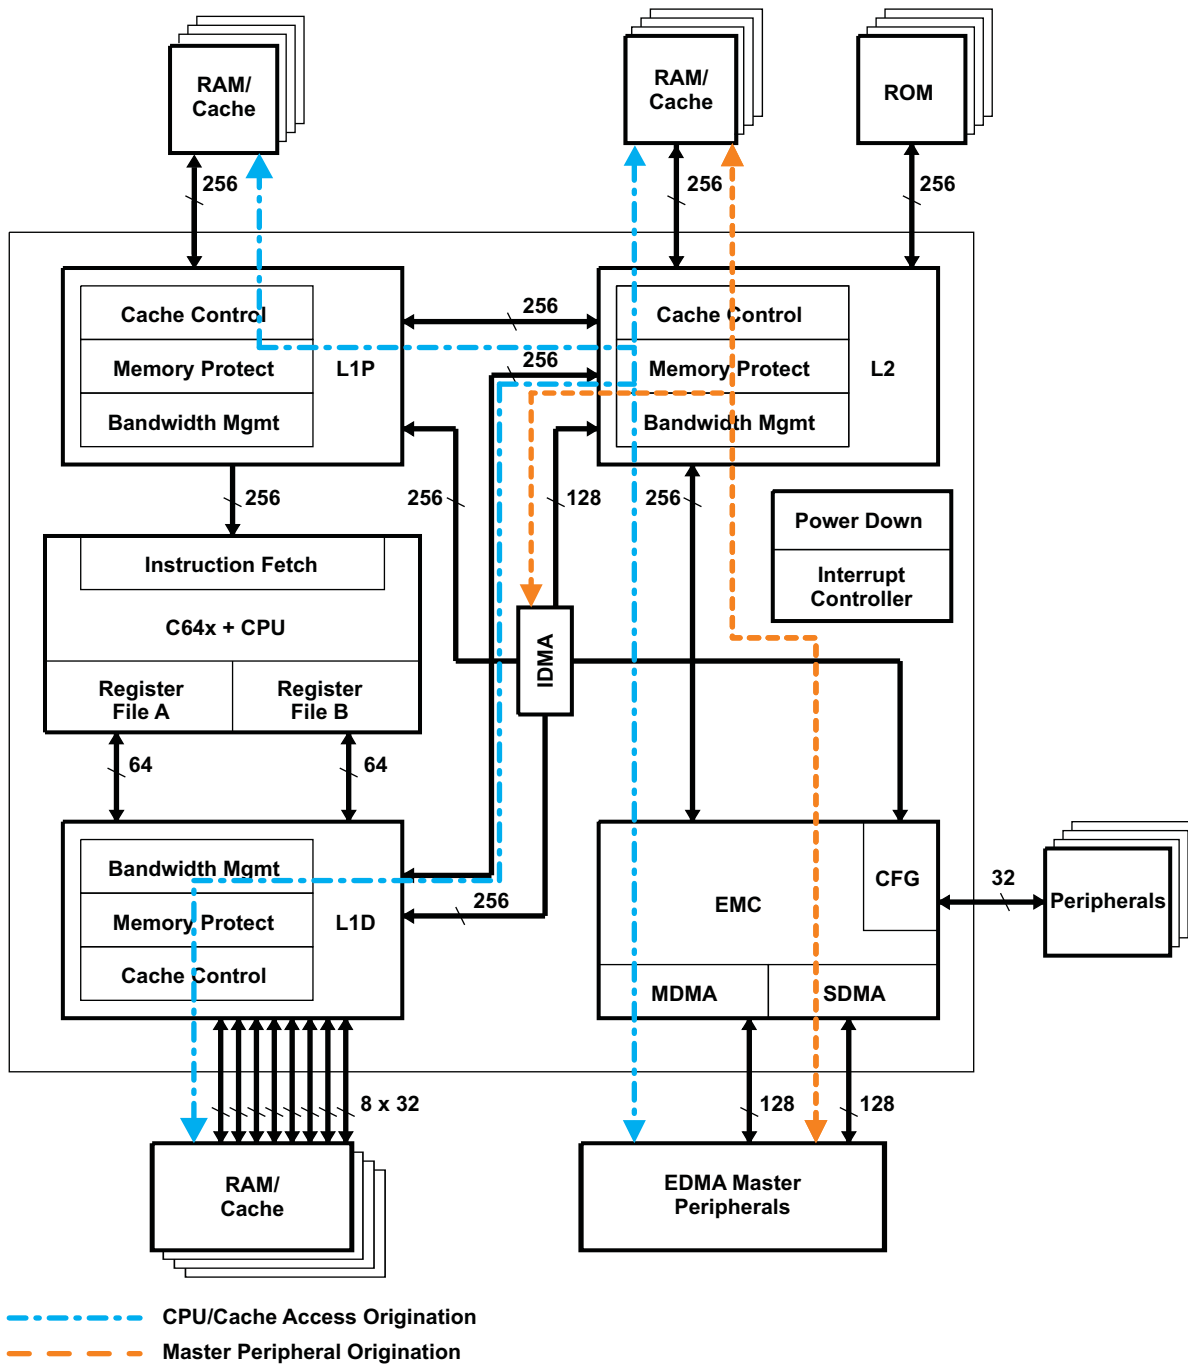
Figure 7. IDMA, SDMA, and MDMA Paths

Ideally, the MDMA (the blue lines in [Figure 7](#)) and SDMA/IDMA paths (the orange lines in [Figure 7](#)) operate independently with minimal interference. Normally, MDMA accesses may stall for extended periods of time (clock cycles) due to expected system level delays (e.g., bandwidth limitations, DDR2 memory refreshes). However, when using L2 as RAM, SDMA and/or IDMA accesses to L2/L1 may experience unexpected stalling in addition to the normal stalls seen by the MDMA interface. For latency-sensitive traffic, the SDMA stall can result in missing real-time deadlines.

NOTE: SDMA/IDMA accesses to L1P/D will not experience an unexpected stall if there are no SDMA/IDMA accesses to L2. Unexpected SDMA/IDMA stalls to L1 happen only when they are pipelined behind L2 accesses.

[Figure 7](#) is a simplified view for illustrative purposes only. The IDMA/SDMA path (orange lines) can also go to L1D/L1P memories and IDMA can go to the DSP CFG peripherals. MDMA transactions (blue lines) can also originate from L1P or L1D through the L2 controller or directly from the DSP.

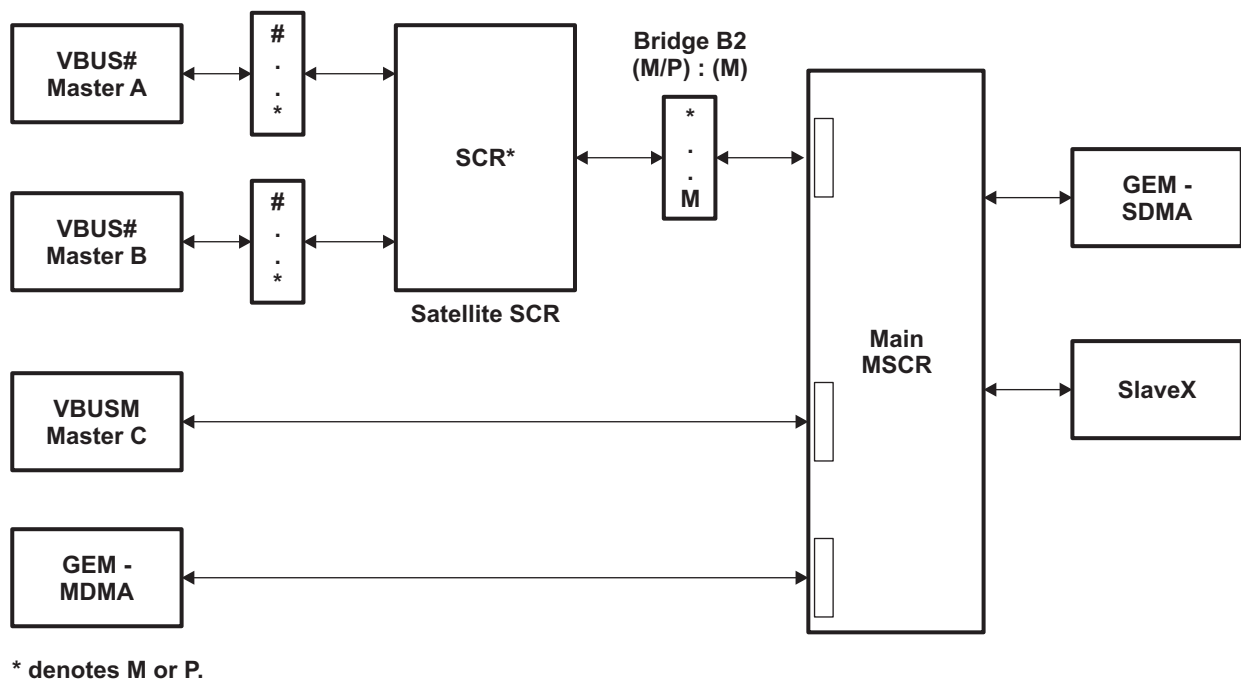
Figure 8. Data Pipelined SCR

A load (either cacheable or non-cacheable) from another core's L1D or L2 memory can additionally create a deadlock condition. When the load is issued, the read command is propagated to the SDMA port of the other core through a shared cross-connect bridge that is shared with either TC0 or TC1 and GEM MDMA traffic from two other GEMs. When the load is issued, if a victim is generated in L1D cache, then the SDMA may stall until the load completes. If other masters are issuing commands through the shared cross-connect bridge, then the bridge may fill due to the stalled SDMA before the read command can propagate through the bridge and complete. The C6472 device has two cross-connect bridges (Xconn1 and Xconn2). GEMs 0, 1, 2, and TC0 use cross-connect bridge 1. GEMs 3, 4, 5, and TC1 use cross-connect bridge 2. In summary, a deadlock can occur if the following is true:

- GEMx issues a read to any of other GEM's L1D or L2 SRAM through cross-connect bridge 1 or 2.
- Any of the other GEMs or TCx on the same cross-connect bridge issue commands to GEMx L2.

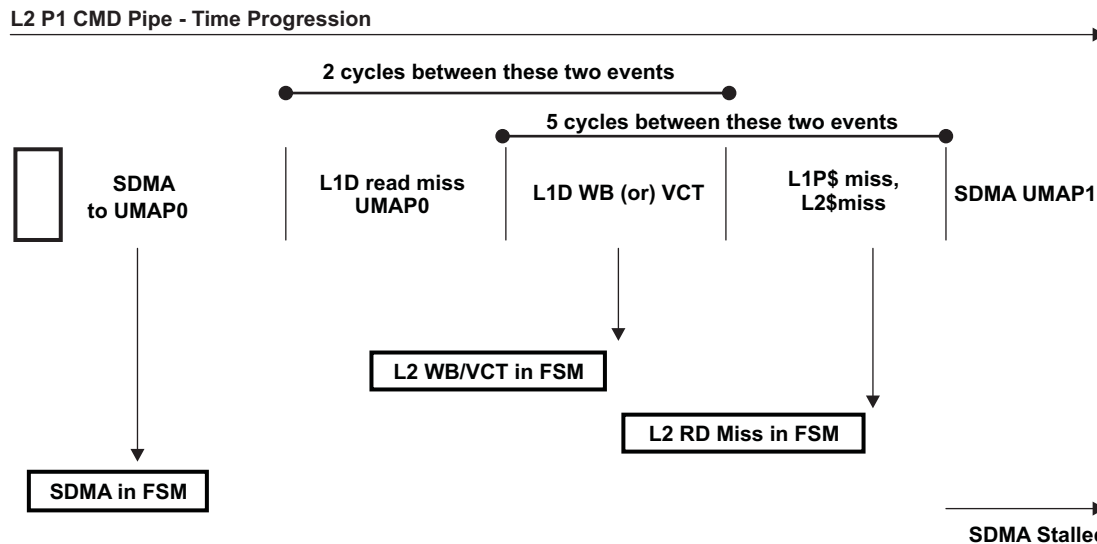
Figure 9. Timing Between Transactions

The SDMA in item 1 sets up a bank conflict for the L1D\$ read in item 2. The L1D\$ allocate in item 2 prevents the L1D\$ write/victim (item 3) from advancing, so it is stuck in the pipeline. This occurs at the same time as an L1P\$ allocate that also results in an L2 access to external memory (item 4), which is also in the same pipeline stage as the L1D\$ write/victim (item 3). At this point, the L1P\$ allocate (item 4) advances to the next pipeline stage but the L1D\$ write/victim (item 3) is still stuck waiting on the L1D\$ allocate (item 2). This now sets up the pipeline for the stall condition, which is actually triggered by an SDMA to UMAP1 (item 5). This is what causes further SDMAs to stall. After the L1P\$ allocate (item 4) is complete, item 2 resolves, allowing item 3 to resolve, thus, freeing the SDMA pipeline again. Therefore, the stall is effectively for the length of the L1P\$ allocate in item 4.

Note that the above four conditions do not guarantee that you will see a stall; it may stall depending on the timing between the transactions. Items 2 and 3 must occur within two CPU cycles of each other and items 3 and 4 must occur within five CPU cycles of each other. shows the timing relationship.

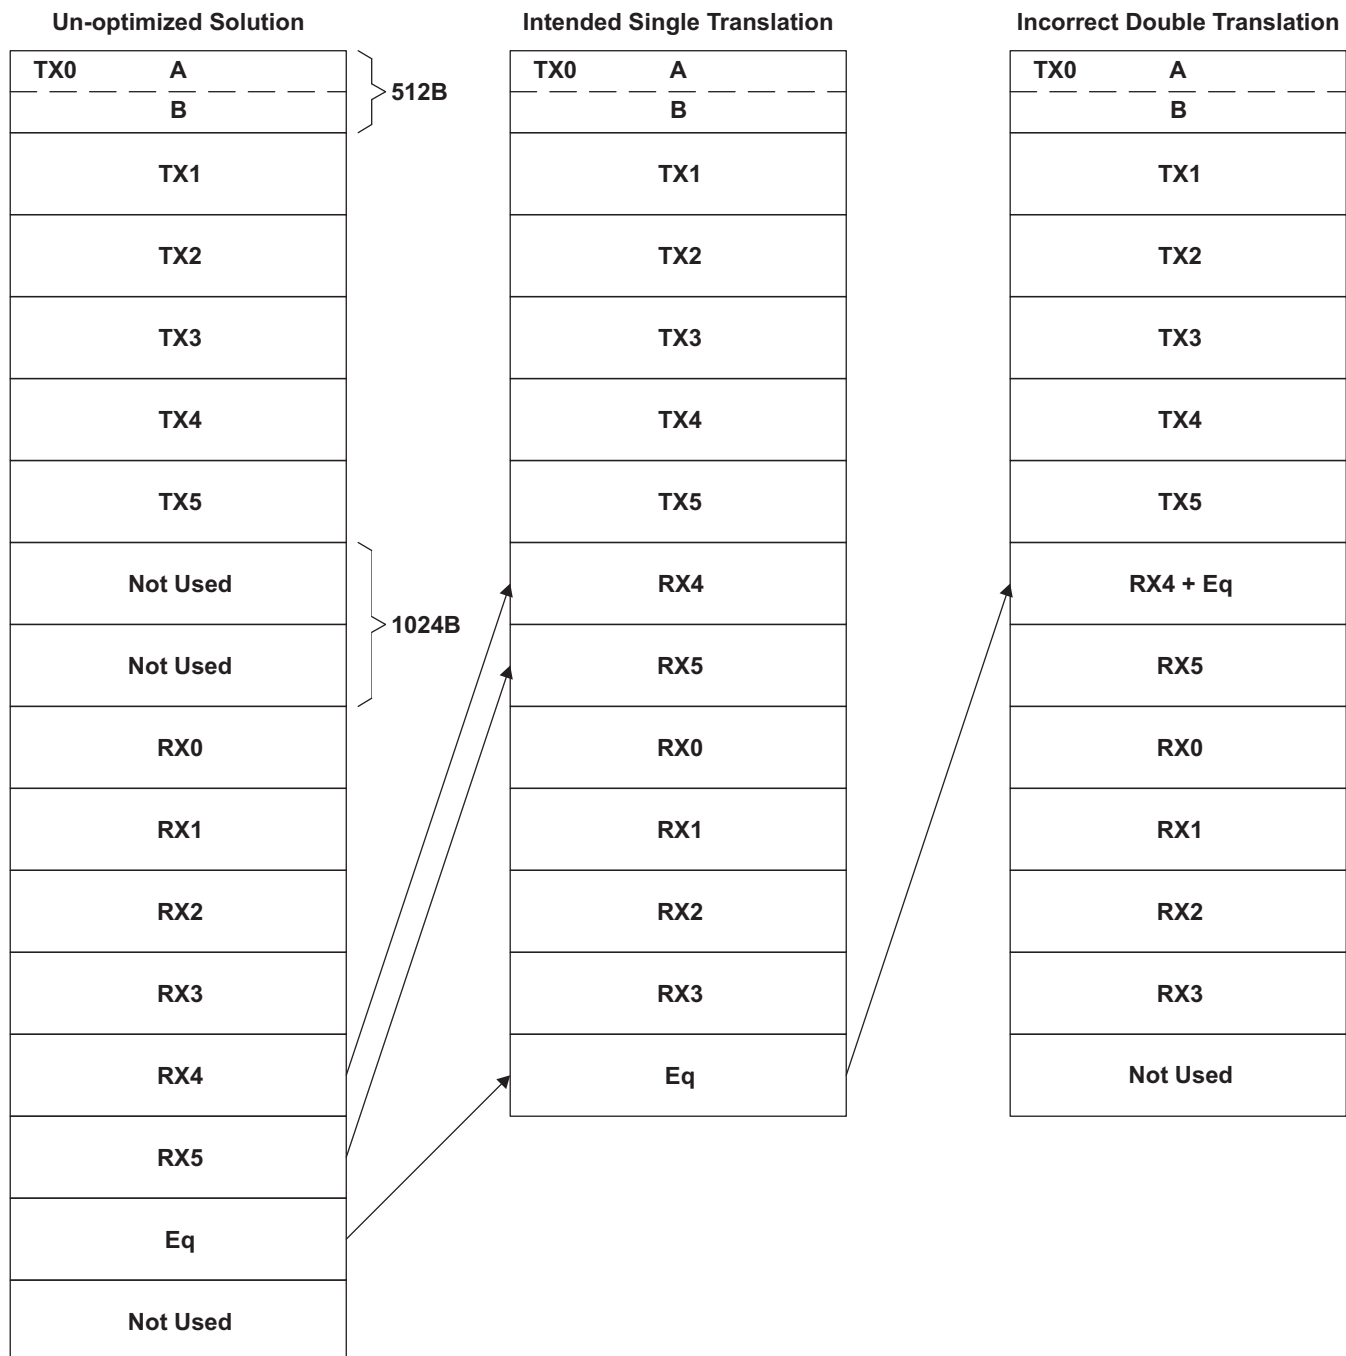
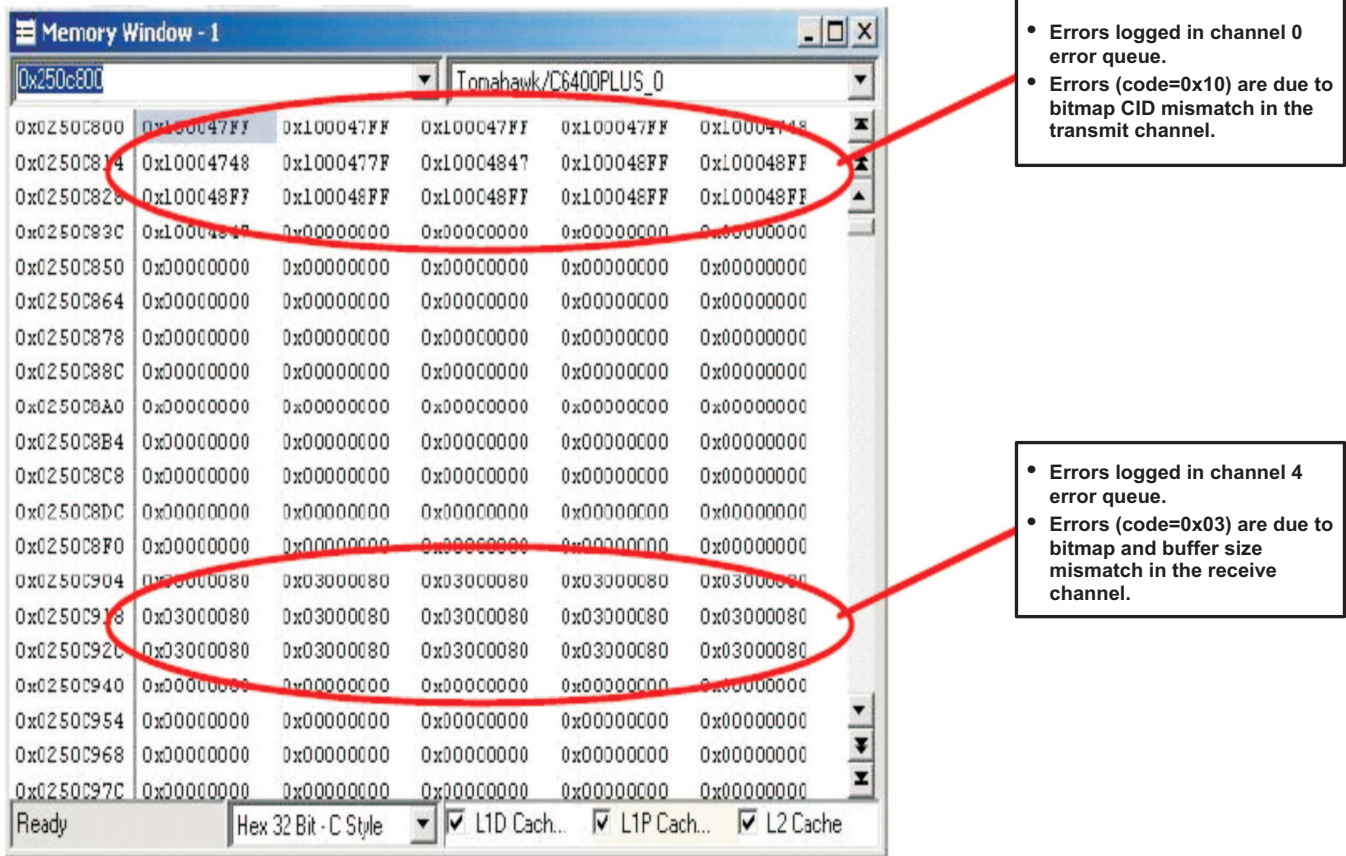
The bitmap memory for receive channel 4 will be corrupted if an error occurs on any TSIP channel. This results in the receive data for channel 4 (associated with GEM4) being lost for frame intervals beginning with the first error until the issue is addressed and the receive channel 4 bitmap has been reinitialized and activated. Corruption is due to a double translation of the address going to the memory used for bitmaps and error queues (see [Figure 14](#)). [Figure 15](#) shows a bitmap memory snapshot where the TSIP receive channel 4 bitmap has been corrupted.

If an error occurs during execution of the normal application, then a TSIP error interrupt is asserted for every channel that experiences an error. This error interrupt is asserted to the corresponding DSP subsystem. The DSP subsystem that receives the error interrupt must correct the error condition to avoid prolonged loss of data on its own channel as well as on channel 4. When DSP subsystem 4 receives an error it must determine whether the error is due to its own failure and, if it is, that error must be corrected first.
