# TMS320F28004x Real-Time MCUs Silicon Errata

## Silicon Revisions B, A, 0

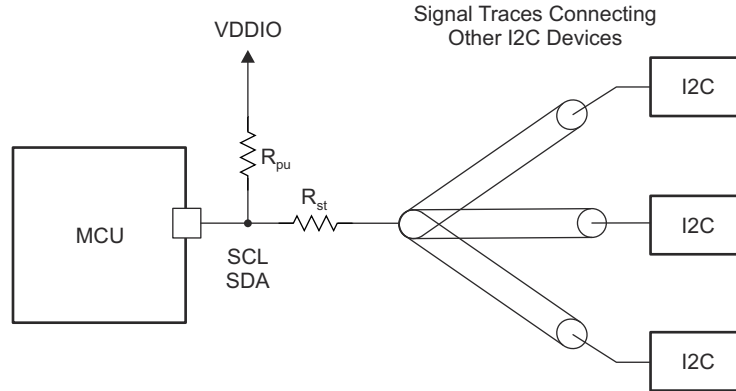
**Figure 3-4. Placement of Series Termination Resistor and Pullup Resistor**

The SDA and SCL outputs are implemented with push-pull 3-state output buffers rather than open-drain output buffers as required by I2C. While it is possible for the push-pull 3-state output buffers to behave as open-drain outputs, an internal timing skew issue causes the outputs to drive a logic-high for a duration of 0–5 ns before the outputs are disabled. The unexpected high-level pulse will only occur when the SCL or SDA outputs transition from a driven low state to a high-impedance state and there is sufficient internal timing skew on the respective I2C output.

This short high-level pulse injects energy in the I2C signals traces, which causes the I2C signals to sustain a period of ringing as a result of multiple transmission line reflections. This ringing should not cause an issue on the SDA signal because it only occurs at times when SDA is expected to be changing logic levels and the ringing will have time to damp before data is latched by the receiving device. The ringing may have enough amplitude to cross the SCL input buffer switching threshold several times during the first few nanoseconds of this ringing period, which may cause clock glitches. This ringing should not cause a problem if the amplitude is damped within the first 50 ns because I2C devices are required to filter their SCL inputs to remove clock glitches. Therefore, it is important to design the PCB signal traces to limit the duration of the ringing to less than 50 ns. One possible solution is to insert series termination resistors near the SCL and SDA terminals to attenuate transmission line reflections.

This issue may also cause the SDA output to be in contention with the slave SDA output for the duration of the unexpected high-level pulse when the slave begins its ACK cycle. This occurs because the slave may already be driving SDA low before the unexpected high-level pulse occurs. The glitch that occurs on SDA as a result of this short period of contention does not cause any I2C protocol issue but the peak current applies unwanted stress to both I2C devices and potentially increases power supply noise. Therefore, a series termination resistor located near the respective SDA terminal is required to limit the current during the short period of contention.

A similar contention problem can occur on SCL when connected to I2C slave devices that support clock stretching. This occurs because the slave is driving SCL low before the unexpected high-level pulse occurs. The glitch that occurs on SCL as a result of this short period of contention does not cause any I2C protocol issue because I2C devices are required to apply a glitch filter to their SCL inputs. However, the peak current applies unwanted stress to both I2C devices and potentially increases power supply noise. Therefore, a series termination resistor located near the respective SCL terminal is required to limit the current during the short period of contention.

Insert series termination resistors on the SCL and SDA signals and locate them near the SCL and SDA terminals. The SCL and SDA pullup resistors should also be located near the SCL and SDA terminals. The placement of the series termination resistor and pullup resistor should be connected as shown in [Figure 3-4](#).
