TMS320DM369

Digital Media System-on-Chip (DMSoC)

Silicon Revision 1.2

Silicon Errata

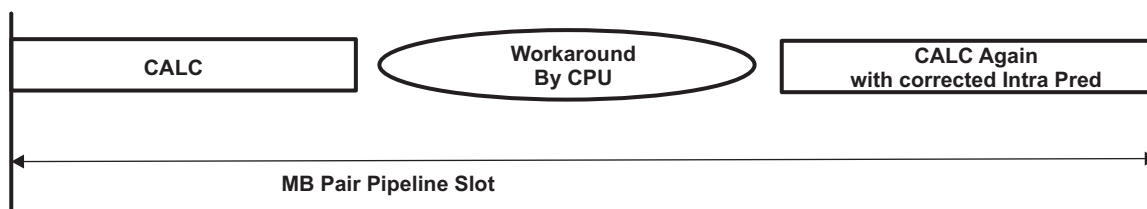
Figure 2. MB Pair Pipeline Slot Example

Details During the calculation of the intra prediction block, pixel values can reach 512 or higher. However, the computation engine has precision only enough to hold values equal to 511 or less.

- H.264 Encode or Decode
- Intra_16x16_Plane mode MB
- Luma blocks *only*; it does not affect Chroma blocks
- If the prediction block generated using the Intra_16x16_Plane mode has a pixel value of 512 or higher

- In Encode, an incorrect (but legal) bitstream will be generated, and a mismatch will happen between the Encoder and Decoder resulting in significant quality degradation.
- In Decode, the reconstructed macroblock will be incorrect.
- If the following MBs are intra referring to this MB, the error is propagated spatially within the picture.
- If the following pictures refer to this MB, the error is propagated temporally to the following pictures.

During a MB pipeline slot, a CALC is done, a workaround by CPU, and CALC again with corrected intra prediction macroblock (see [Figure 2](#)).

If the MB is of intra 16x16 plane mode, perform the following steps:

1. Let CALC run.
2. Wait for CALC to complete
3. After CALC completes, switch BFSW for iprdbuf : CALC → DMA
4. Check and correct Intra Prediction (for more details, see the *Check and Correct Intra Prediction* section below)
5. Switch BFSW for iprdbuf : DMA → CALC
6. Switch BFSW for calcmbuf : CALC → DMA
7. Set up CALC commands with intra mode for IQ/IT and inter mode for prediction (for more details, see the *Set up CALC Commands with Intra mode for IQ/IT and Inter Mode for Prediction* section below)
8. If MBAFF, retrigger DMA for upper row data
9. Switch BFSW for calcmbuf : DMA → CALC
10. Switch BFSW for reconbuf : LPF → DMA
11. Read left reconstructed column
12. Switch BFSW for reconbuf : DMA → LPF
13. Switch BFSW for calcsbuf : CALC → DMA
14. Set back left reconstructed column
15. Switch BFSW for calcsbuf : DMA → CALC
16. Re-run CALC
17. Wait for CALC to complete
