## ABSTRACT

This document describes the known exceptions to the functional specifications (advisories).

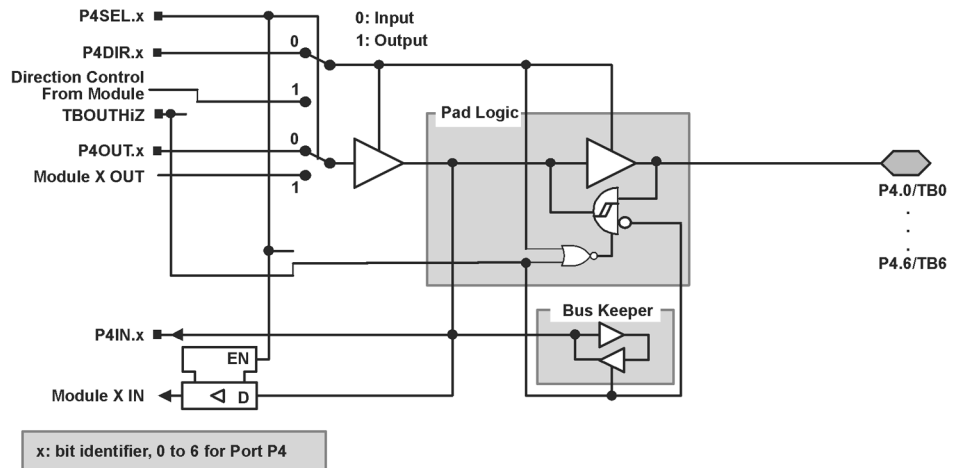
Port Realization With TB3 Bug

<b>Workaround</b>	Switch capture/compare mode to capture mode before the CCRx register increment. Switch back to compare mode afterward.
<b>TB3</b>	<b><i>TB Module</i></b>
<b>Category</b>	Functional
<b>Function</b>	Timer_B Port is switched to 3-state independent of selected function
<b>Description</b>	Incorrect 3-state function of Ports P4.0/TB0 through P4.6/TB6 (TBoutHiZ control). If TBoutHiZ is set to high, all ports P4.0/TB0 through P4.6/TB6 are set to 3-state, independent of the P4SEL.x control signals. This means a port P4.x is switched to 3-state with TBoutHiZ, even if it is not selected for Timer_B function. In addition, the ports P4.0/TB0 through P4.6/TB6 are switched to 3-state with TBoutHiZ, even if the port direction (direction control from module) is set to input. This is in accordance with the specification description but, nevertheless, is an unexpected behavior.
<b>Workaround</b>	No workaround.  Port function as specified
