Errata

MSP430F2618 Microcontroller

This document describes the known exceptions to the functional specifications (advisories).

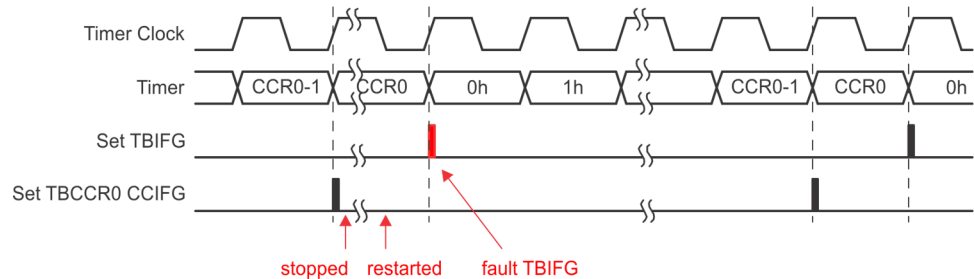
Function TBIFG Flag is erroneously set after Timer B restarts in Up Mode

Description In Up Mode, the TBIFG flag should only be set when the timer resets from TBCCR0 to zero. However, if the Timer B is stopped at TBR = TBCCR0, then cleared (TBR=0) by setting the TBCLR bit, and finally restarted in Up Mode, the next rising edge of the TBCLK will erroneously set the TBIFG flag.

Workaround None.
