Tiva™ C Series TM4C129x Microcontrollers Silicon Revisions 1, 2, and 3

1 Introduction

This document describes known exceptions to the functional specifications for all of the Tiva™ C Series TM4C129x microcontrollers. Note that some features are not available on all devices in the series, so not all errata may apply to your device. See your device-specific data sheet for more details.

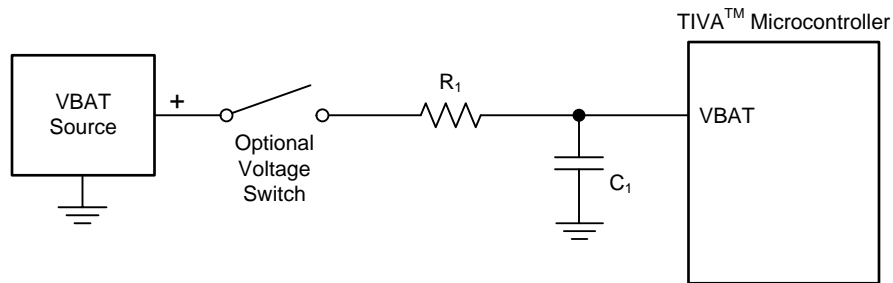
Figure 2. RC Circuit

ELEC#02 *V_{BAT} Supply pin may be Damaged if the pin Voltage Ramps Faster Than 0.7 V/μs*

Description The V_{BAT} supply pin may be damaged if the pin voltage ramps faster than 0.7 V/μs. Fast V_{BAT} ramps are a concern when a battery is being connected or the V_{BAT} supply is hard switched.

Workaround(s) An RC circuit as shown should be added to the V_{BAT} pin to prevent the damage. The R₁ and C₁ should be placed close to the microcontroller for best protection. In systems that do not require Hibernate when the VDD supply is off, the V_{BAT} pin should be tied to the VDD supply, which typically ramps at a rate slower than 0.7 V/μs. The R1 and C1 components are not required for a V_{BAT} supply ramp less than 0.7 V/μs.

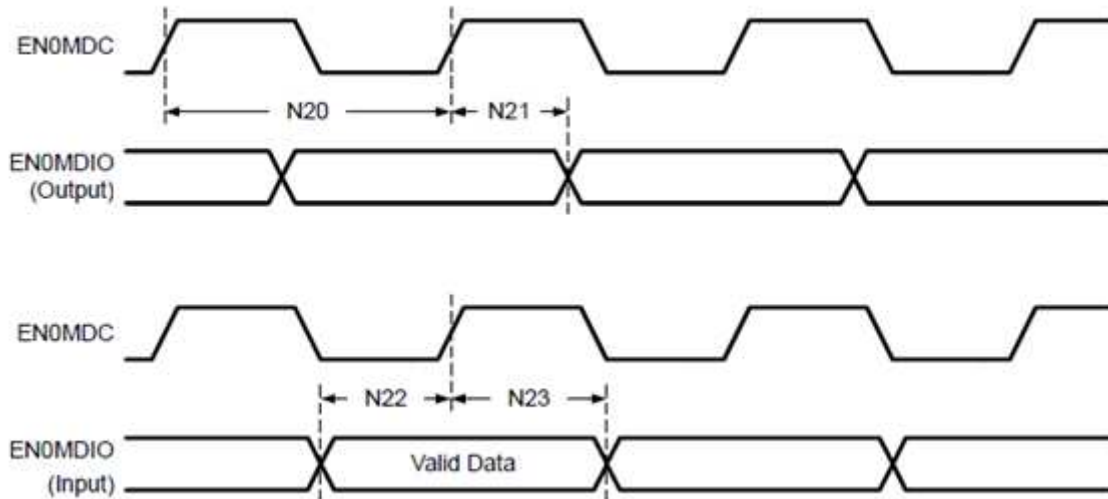
Description: The following timing diagram in the Electrical Characteristics for Ethernet Controller AC Characteristics for MII Serial Management is the corrected diagram.

Workaround(s): None.

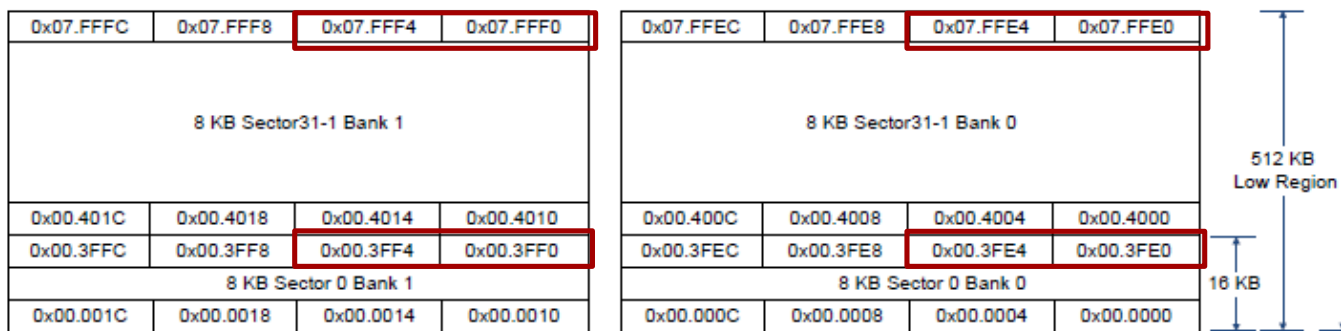
MEM#15 ***Specific Flash Locations in any Sector do not get Erased***
Revision(s) Affected: 1, 2, and 3.

Description: If only one or both of the first two words of the last line of a sector in a bank are programmed, an Erase of entire Sector, Mass Erase of device, or toggle mass erase does not erase the flash back to all 1's. The diagram below shows the affected words in Sector 0 and Sector 31 of the lower 512KB of Flash.

Workaround(s): Program any other word in the Sector-Bank to allow Sector Erase to work.

NOTE: Toggle Mass Erase or Mass Erase will still not work.

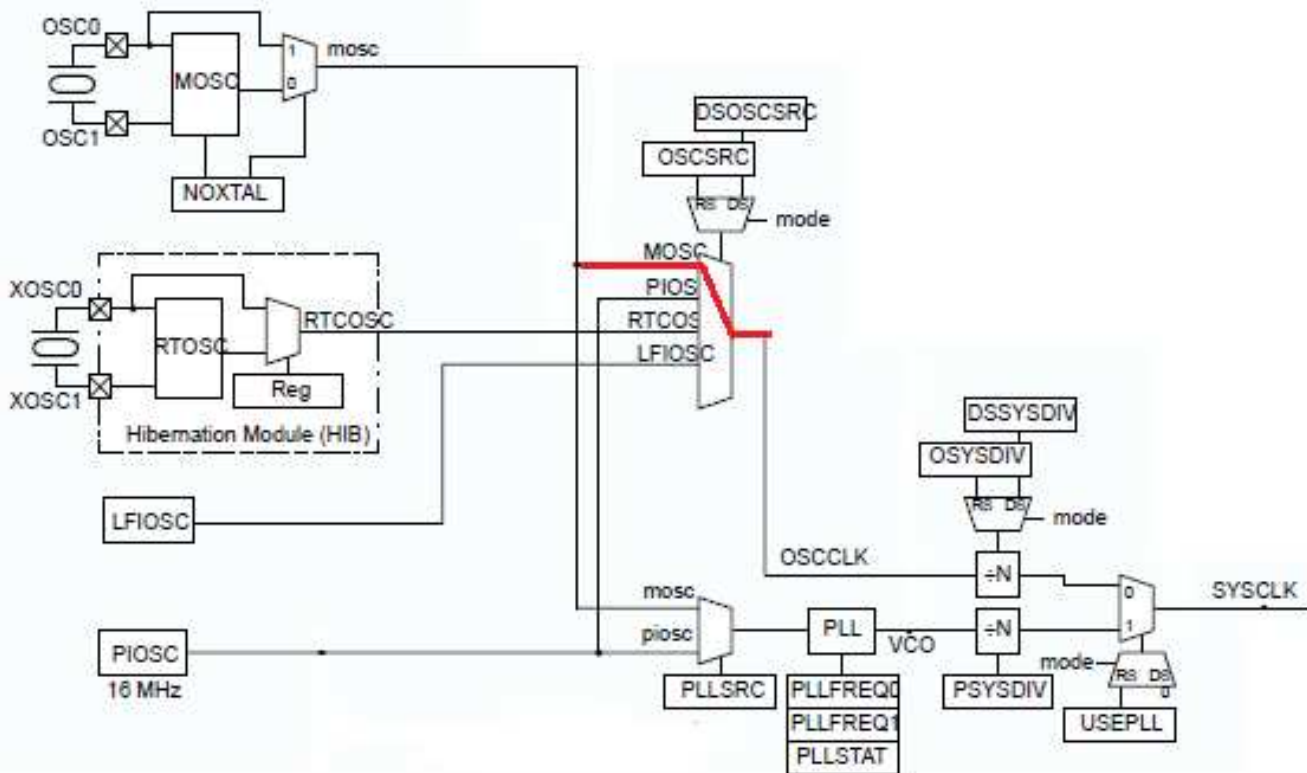
SYSTL#23 MOSC as the Source to OSCCLK may Cause a bus Fault on Reset
Revision(s) Affected: 1, 2, and 3.

Description: MOSC as the source to the OSCCLK may cause a bus fault on reset. This may happen even when using the PLL as SYSCLK and configuring the MOSC as the source for OSCCLK. Please see the following image on the affected clock path.

In TivaWare 2.1.2 or earlier, the SysCtlClockFreqSet sets the PLL source as MOSC when the API is called with the parameter SYSTL_OSC_MAIN. It sets the OSCCLK as MOSC which is not required and may cause this issue. This issue may occur when using the ROM version of the API.

Workaround(s): Do not use MOSC as the OSCCLK source. There are two workarounds for application using SysCtlClockFreqSet API.
