Errata

J784S4 AM69x TDA4VH TDA4AH TDA4VP TDA4AP J742S2 AM69x-27 TDA4VPE TDA4APE Processors Silicon Revision 1.0

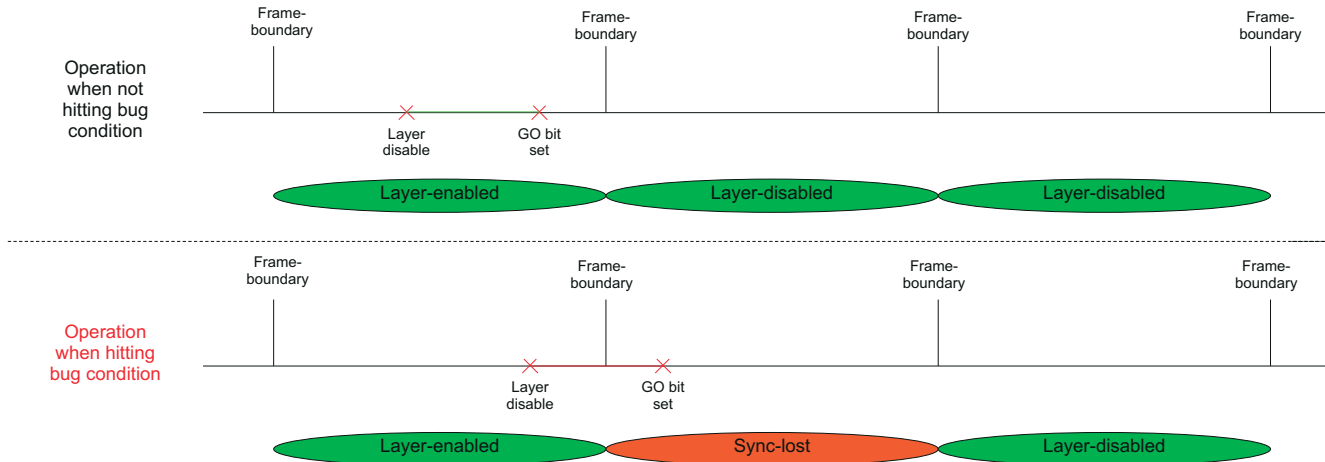
Figure 3-1. Bug Condition

DSS: Disabling a Layer Connected to Overlay May Result in Synclost During the Next Frame

frame. The synclost may result in a corrupted or blank frame (all pixel data sent out of DSS during the frame is 0x0). The occurrence of synclost is dependent on the timing of setting the GO bit (that is DSS_VP_CONTROL[5] GOBIT to 1) vis-à-vis the disabling of the layer. If the “disable layer” MMR write operation and “set GO bit” MMR write operation happens within the same frame boundary, no synclost occurs. If the operations happen across the frame boundary, then synclost occurs (for one frame). The design automatically recovers and returns to normal operation from the next frame after GO bit is set, see [Figure 3-1](#).

Workaround(s):

A sample software workaround pseudo-code is shown on [Figure 3-2](#). In this case, the regular “disable layer” MMR write operation and “set GO bit set” MMR write operation are replaced with macros which implement the software workaround.

- Replace layer disable MMR write operation with a macro which positions the layer to the non-visible area of the OVR
- Track which layers are disabled. This will be used while GO bit is set
- Replace GO bit set MMR write operation with this macro
- First, set GO Bit for the changes in “disable_layer” macro (and any other earlier changes) to take effect
- After the first GO bit set, few idle_cycles (10 DSS functional clock cycles) are necessary before we move to the second step
- In the second step, actually disable the layers based on the previously tracked information
- Set the GO bit for the second time for the disable of the layers to take effect
