# J7200 DRA821 Processor Silicon Revision 1.0, 2.0

## ABSTRACT

This document describes the known exceptions to the functional specifications (advisories). This document may also contain usage notes. Usage notes describe situations where the device's behavior may not match presumed or documented behavior. This may include behaviors that affect device performance or functional correctness.

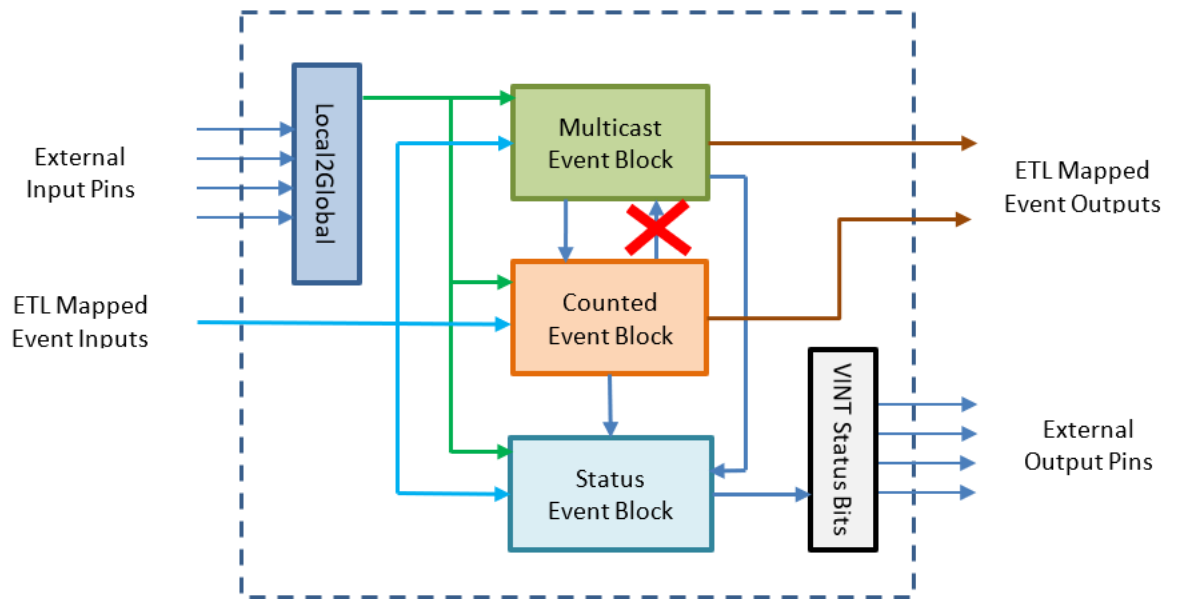
**Figure 3-1. Interrupt Aggregator Version 1.0**

An issue was found after design that could cause the IA to deadlock. The issue occurs when event “loops” occur between these three processing blocks. It is possible to create a situation where a processing block can not output an event because the path is blocked, and since it can not output an event, it can not take any new input events. This inability to take input events prevents the output path from being able to unwind, and thus both paths remain blocked.

it is not possible for a single event to visit any block more than once and thus not possible for paths to become blocked so long as the outputs remain unblocked.

By following the conventions outlined here, the system is safe from looping hazards that can create a deadlock scenario.
