Flash Read Error and Susceptibility for MSP430F54xxA

This document provides a description of the issue referred to as “Flash Read Error” impacting the current version of the MSP430F54xxA device derivatives. It also provides guidance in assessing whether and the extent to which the issue may affect a given application. Specific actions and customer recommendations are set forth in the **PCN #20100910003A**.

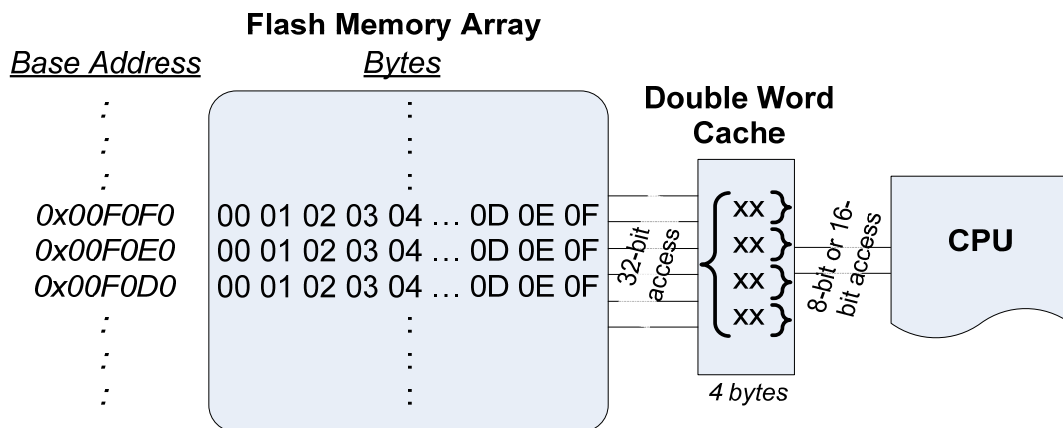
Figure 1. Simplified Cache Architecture and CPU Access

To better describe the flash read error mechanism, it is important to understand the device architecture. The MSP430F54xxA implements a 32-bit cache for memory read operation – e.g. a physical read of the flash memory is performed on 32-bit boundaries; every 4 bytes, which is stored in a cache logic array. These 32-bit values are referred to as “double words”. Memory access by the CPU to individual bytes and words is then done by accessing the cache. This cache architecture is shown in Figure 1.
