# **TMS320TCI6486**

## **Digital Signal Processor**

### **Silicon Revisions 2.1, 2.0, 1.2, 1.1, 1.0**

## **Silicon Errata**

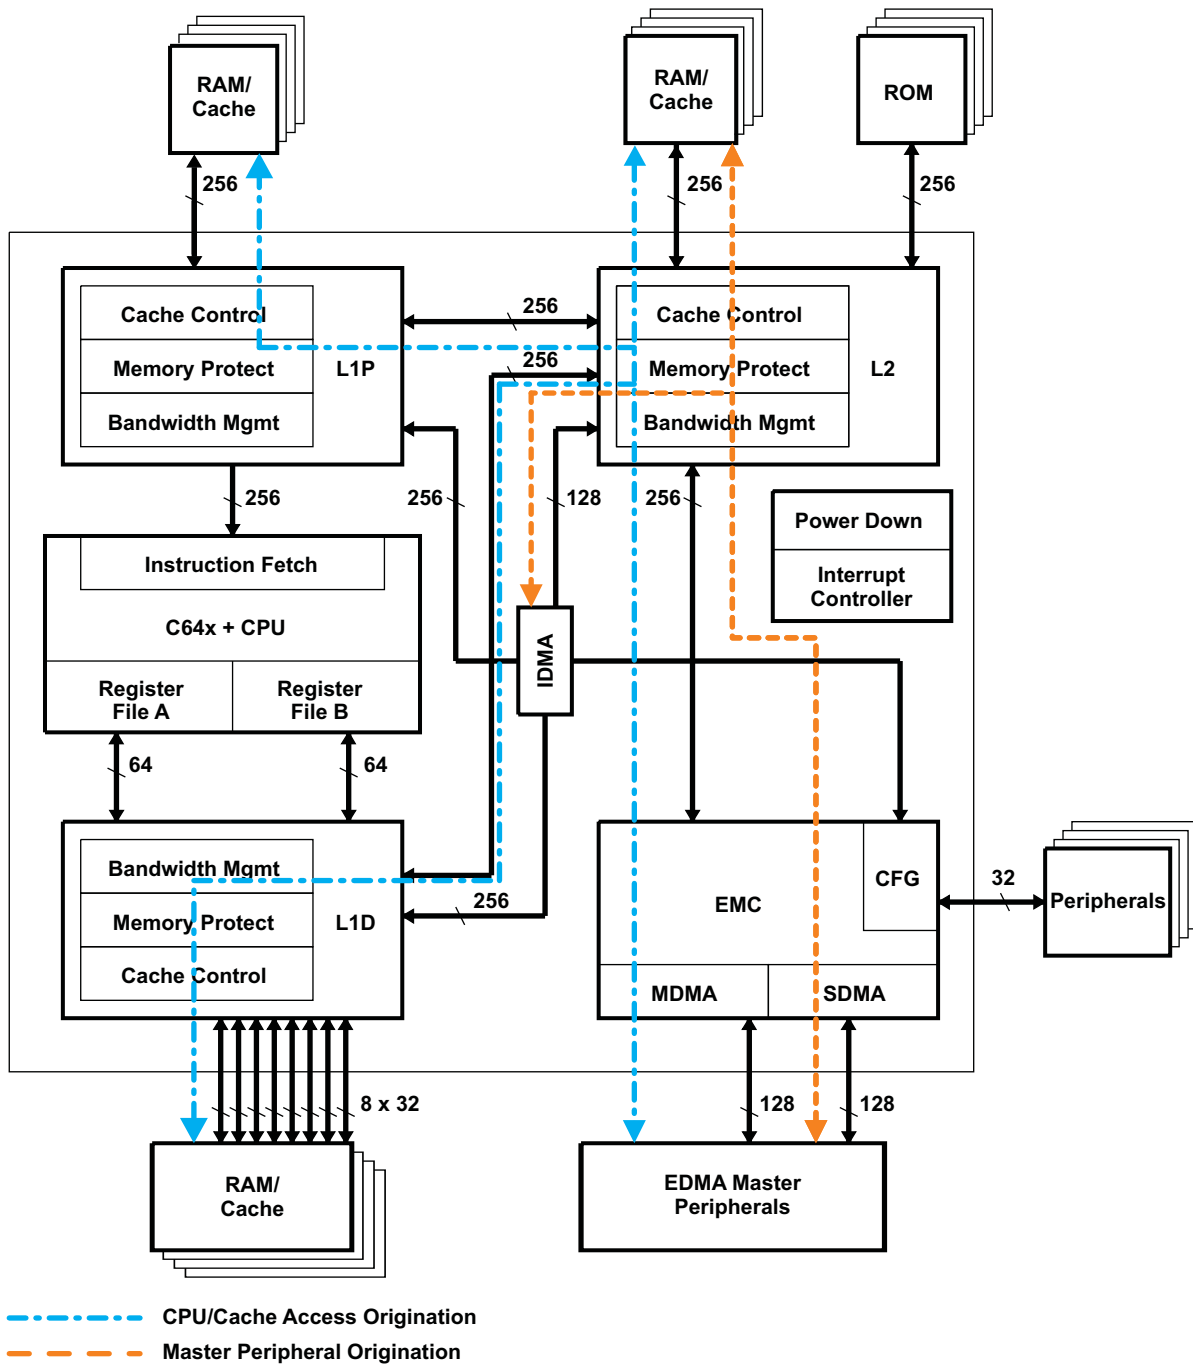
Figure 11. IDMA, SDMA, and MDMA Paths

Ideally, the MDMA (the blue lines in [Figure 11](#)) and SDMA/IDMA paths (the orange lines in [Figure 11](#)) operate independently with minimal interference. Normally, MDMA accesses may stall for extended periods of time (clock cycles) due to expected system level delays (e.g., bandwidth limitations, DDR2 memory refreshes). However, when using L2 as RAM, SDMA and/or IDMA accesses to L2/L1 may experience unexpected stalling in addition to the normal stalls seen by the MDMA interface. For latency-sensitive traffic, the SDMA stall can result in missing real-time deadlines.

[Figure 11](#) is a simplified view for illustrative purposes only. The IDMA/SDMA path (orange lines) can also go to L1D/L1P memories and IDMA can go to the DSP CFG peripherals. MDMA transactions (blue lines) can also originate from L1P or L1D through the L2 controller or directly from the DSP.

SDMA/IDMA stalls may occur during the following scenarios. Each of these scenarios describes expected normal DSP functionality, but the SDMA/IDMA access potentially exhibits additional unexpected stalling.

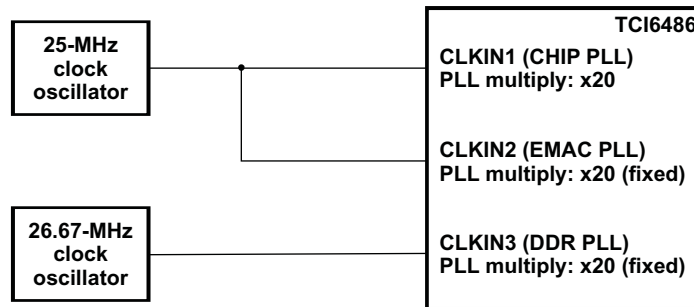
**Figure 14. Expected Customer Implementation**

The following three figures help illustrate the likely hardware changes. [Figure 14](#) shows the clock source diagram that TI expects most customers have implemented. [Figure 15](#) shows the requested implementation change. [Figure 16](#) shows the workaround implementation requirement.

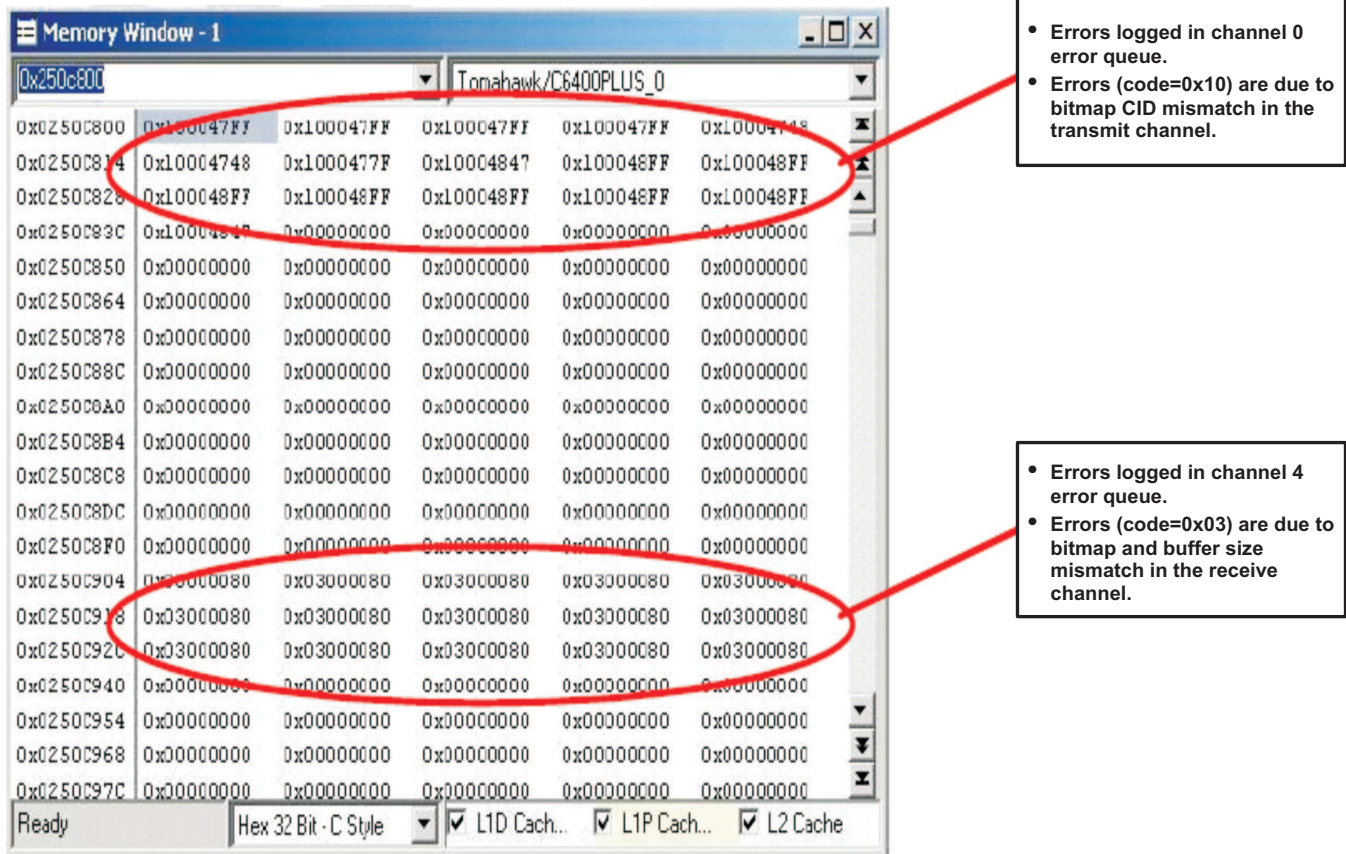
**Details:** The bitmap memory for receive channel 4 will be corrupted if an error occurs on any TSIP channel. This results in the receive data for channel 4 (associated with GEM4) being lost for frame intervals beginning with the first error until the issue is addressed and the receive channel 4 bitmap has been reinitialized and activated. Corruption is due to a double translation of the address going to the memory used for bitmaps and error queues (see [Figure 17](#)). [Figure 18](#) shows a bitmap memory snapshot where the TSIP receive channel 4 bitmap has been corrupted.
