TMS320DM6446

Digital Media System-on-Chip

Silicon Revisions 2.3, 2.1, 1.3, 1.2, and 1.1

Silicon Errata

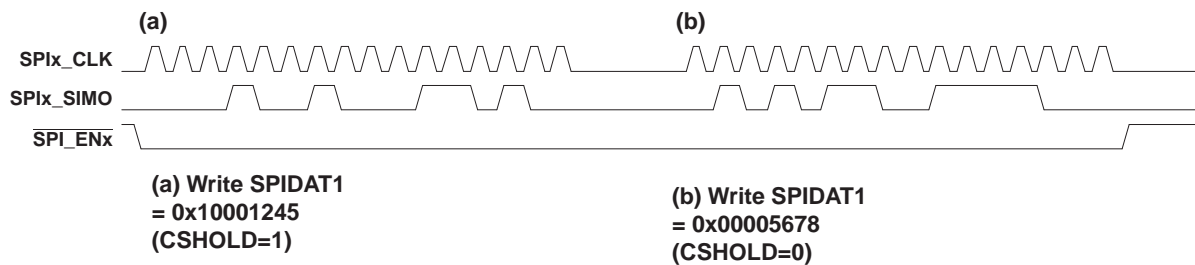
Figure 2. Expected CSHOLD Behavior

According to the SPI specification, the following sequence should produce the expected result as illustrated in Figure 2:

- Write 0x10001234 to SPIDAT1 for transmission of 0x1234 (CSHOLD = 1)
- Write 0x00005678 to SPIDAT1 for transmission of 0x5678 (CSHOLD = 0)

Instead, what actually occurs is that SPI_ENx is momentarily de-asserted at the beginning of the second write, as illustrated in Figure 3.

Both Figure 2 and Figure 3 assume that SPIDAT1 is written using a single 32-bit write instruction. If SPIDAT1 is instead written using an 8-bit or 16-bit instruction to write to the CSHOLD field, followed by a 16-bit write to the transmit shift register field of SPIDAT1, then what actually occurs is illustrated in Figure 4. This is the same case illustrated in Figure 3 except that the de-assertion of SPI_ENx lasts for the duration between writing a '0' to the CSHOLD field and writing new data to the transmit shift register.
