**OMAP-L137
C6000 DSP+ARM Processor
Silicon Revisions 3.0, 2.1, 2.0, 1.1, and 1.0**

Silicon Errata

Literature Number: SPRZ291
October 2008–Revised June 2014

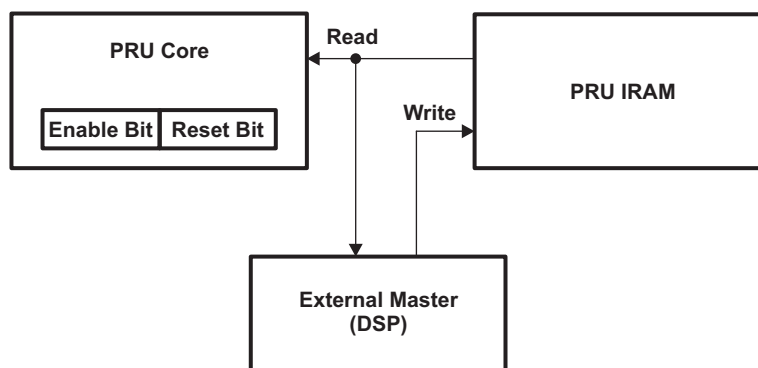
Figure 4. PRU and DSP Block Diagram

The ARM reset vector table is located in the ARM's local RAM, however the ARM local RAM can only be accessed by two bus masters: ARM and PRU0. Therefore, the DSP must program PRU0 to copy the desired reset vector table into the ARM's local RAM.

The PRU instructions are located inside of an instruction RAM (IRAM) which is initialized by the DSP during ROM boot (see Figure 4). After the instructions are stored to IRAM, the PRU is reset and enabled to execute its instructions. In this case, the PRU is instructed to initialize the ARM reset vector table.

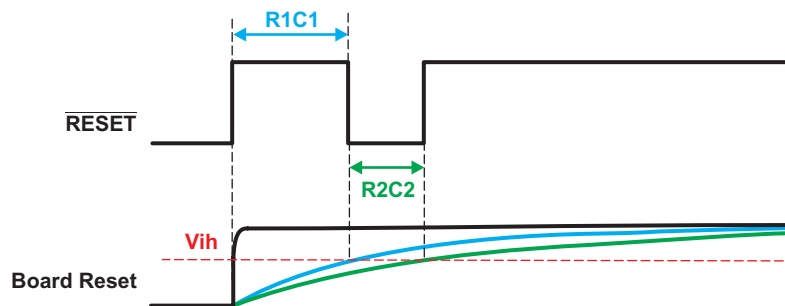
Figure 11. RESET Signal vs Board Reset

This is possible because each RC load connected to the board reset control signal can output a different rising-edge waveform. With increasing RC load, the resulting control signal will reach the Schmitt buffers' V_{ih} level at a later point in time. Figure 11 shows the relationship between the board reset signal and the RESET signal produced by the circuit. The blue and green lines represent the voltage as seen by the Schmitt buffers. The output voltage of a charging RC circuit is defined as: $V_o = V_i * (1 - e^{-t / RC})$

Given ideal conditions, a 3.3V board reset signal, and an input buffer V_{ih} of 1.4V, the following set of component values would generate an initial RESET high period ($R1C1$ region) of approximately 2ms and a RESET low period ($R2C2$ region) of approximately 0.5ms:

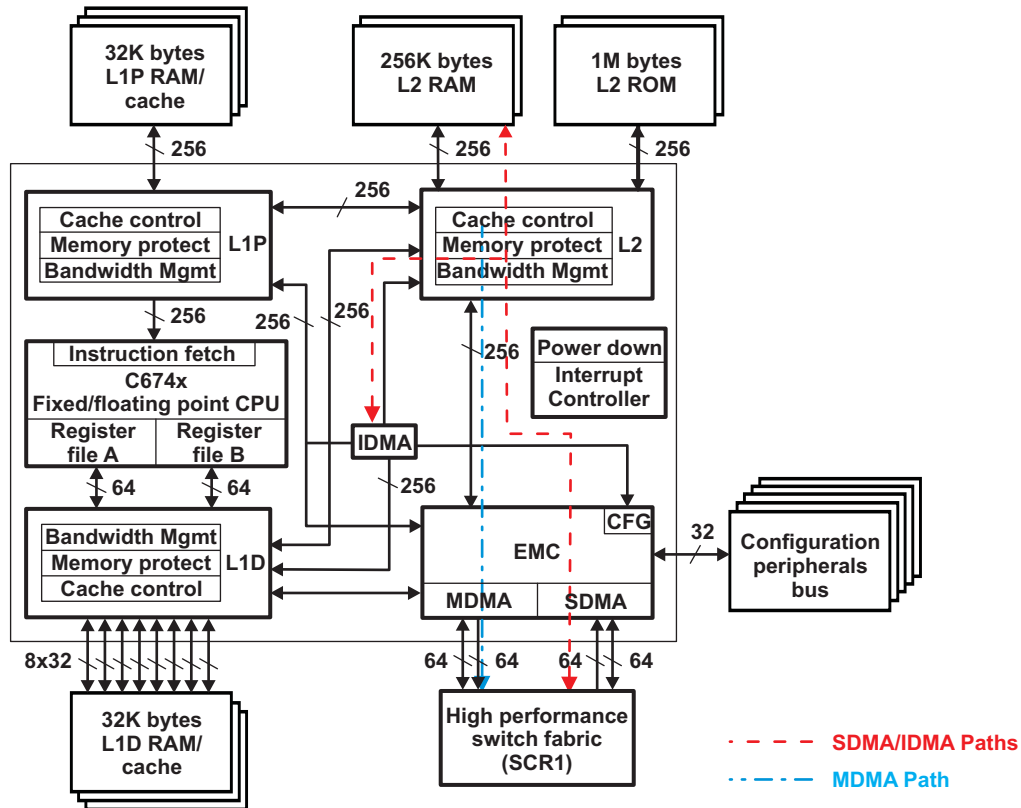
Figure 14. C674x Megamodule

Ideally, the MDMA (dashed-dotted line in [Figure 14](#)) and SDMA/IDMA paths (dashed lines in [Figure 14](#)) operate independently with minimal interference. Normally MDMA accesses may stall for extended periods of time due to expected system level delays (for example, bandwidth limitations). However, when using L2 as RAM, SDMA and IDMA accesses to L2/L1 may experience unexpected stalling in addition to the normal stalls seen by the MDMA interface. For latency-sensitive traffic, the SDMA stall can result in missing real-time deadlines. In a more severe case, the SDMA stall can produce a deadlock condition in the device. An IDMA stall cannot produce a deadlock condition.

Note: SDMA/IDMA accesses to L1P/D will not experience an unexpected stall if there are no SDMA/IDMA accesses to L2. Unexpected SDMA/IDMA stalls to L1 happen only when they are pipelined behind L2 accesses. Additionally, the deadlock scenario will be avoided if there are no SDMA accesses to L2.

The duration of the SDMA/IDMA stalls depend on the quantity/characteristics of the L1/L2 cache and the MDMA traffic in the system. Therefore, it is difficult to predict if stalling will occur and for how long.
