OMAP5912
Applications Processor
Silicon Errata

SPRZ209K
December 2003 – Revised December 2007

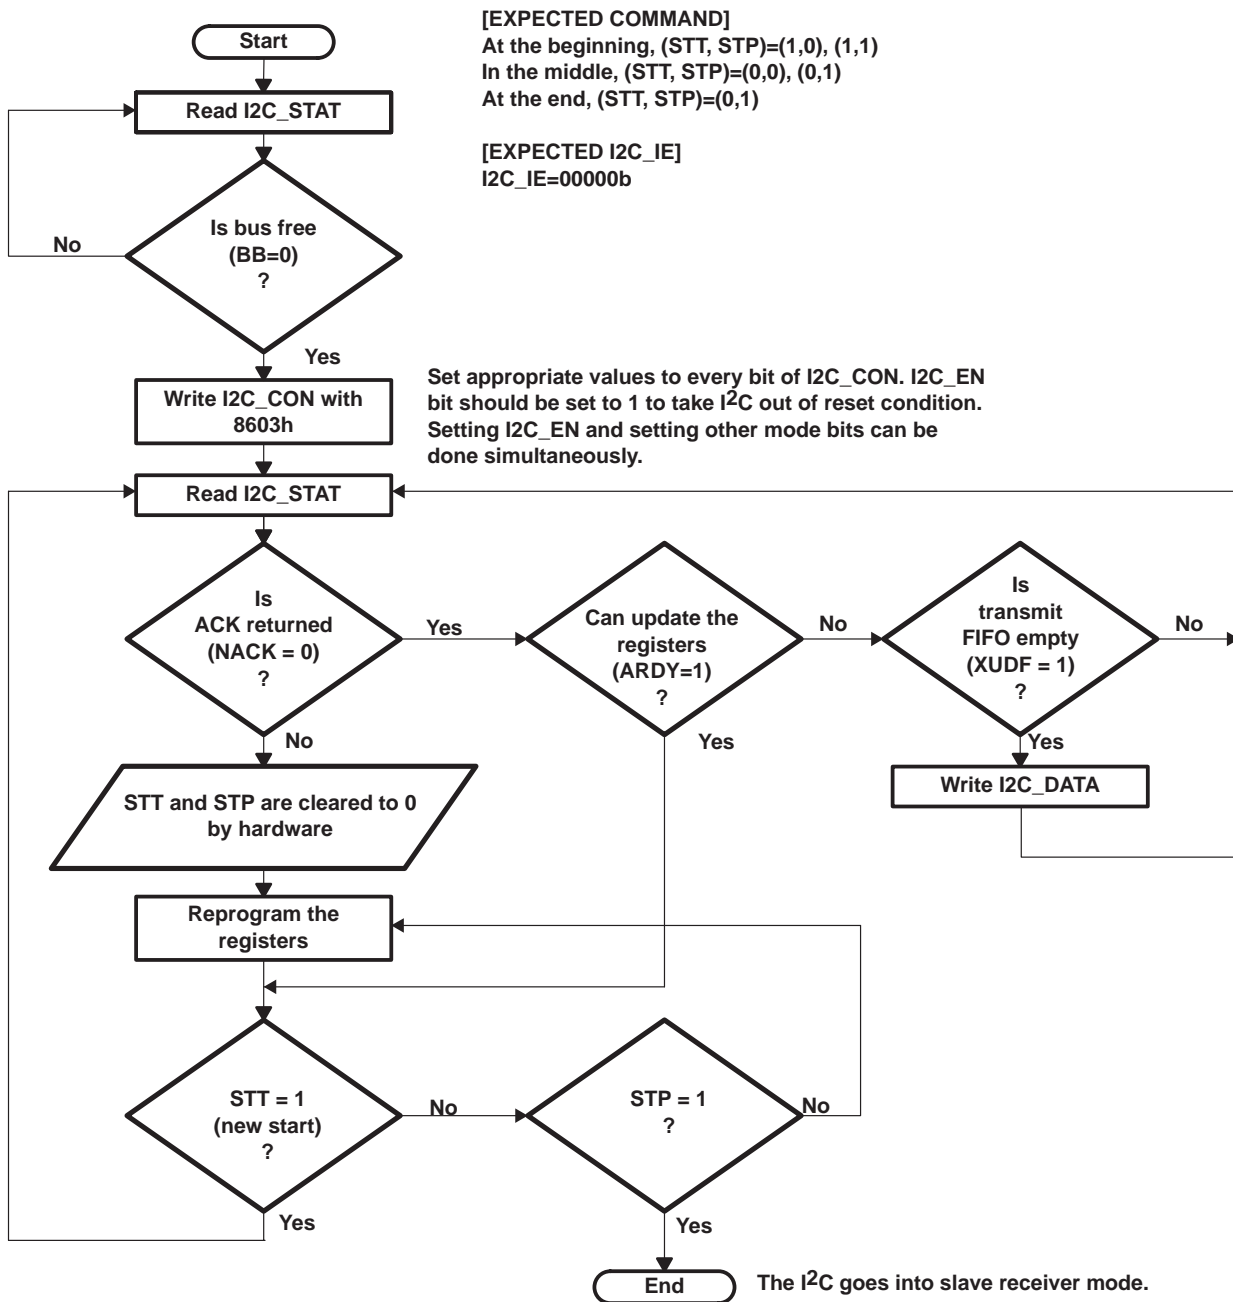
Figure 7. Master Transmitter Mode Polling Flow Diagram

I²C Random Duplication of Byte When Sending Long Messages (Continued)

Figure 7 and Figure 8 show the flowcharts of master transmit operation in polling and interrupt modes.

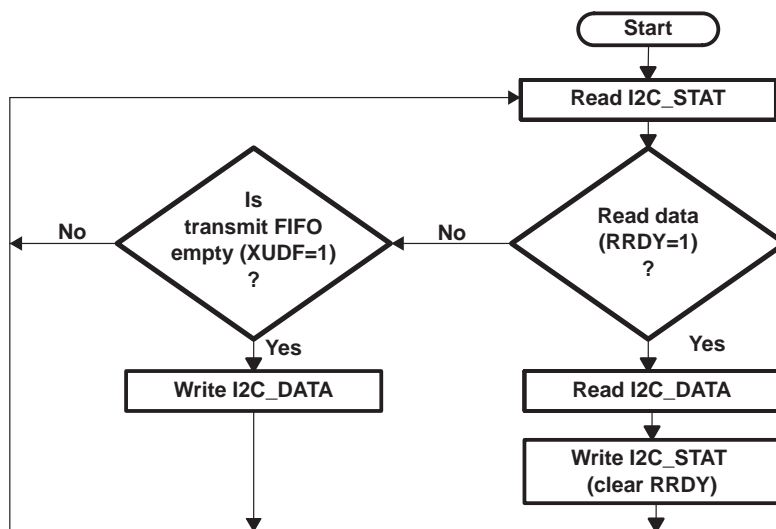
Figure 9. Slave Transmitter/Receiver Mode Polling Flow Diagram

I²C Random Duplication of Byte When Sending Long Messages (Continued)

Figure 9 and Figure 10 show the flowcharts of slave transmit/receive operation in interrupt and polling modes.

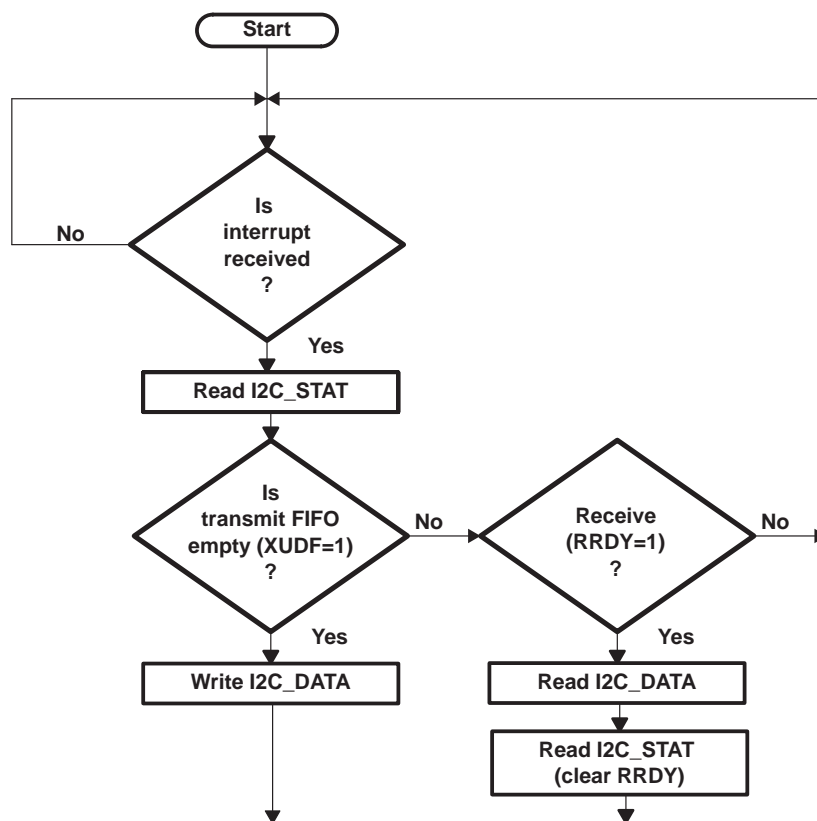
Figure 10. Slave Transmitter/Receiver Mode Interrupt Flow Diagram

I²C Random Duplication of Byte When Sending Long Messages (Continued)

This exception will not be fixed in future silicon revisions.
