AM389x Sitara™ ARM® Microprocessors (MPUs) Silicon Revisions 2.1, 2.0, 1.1, 1.0

Silicon Errata

Literature Number: SPRZ327H
November 2010–Revised March 2015

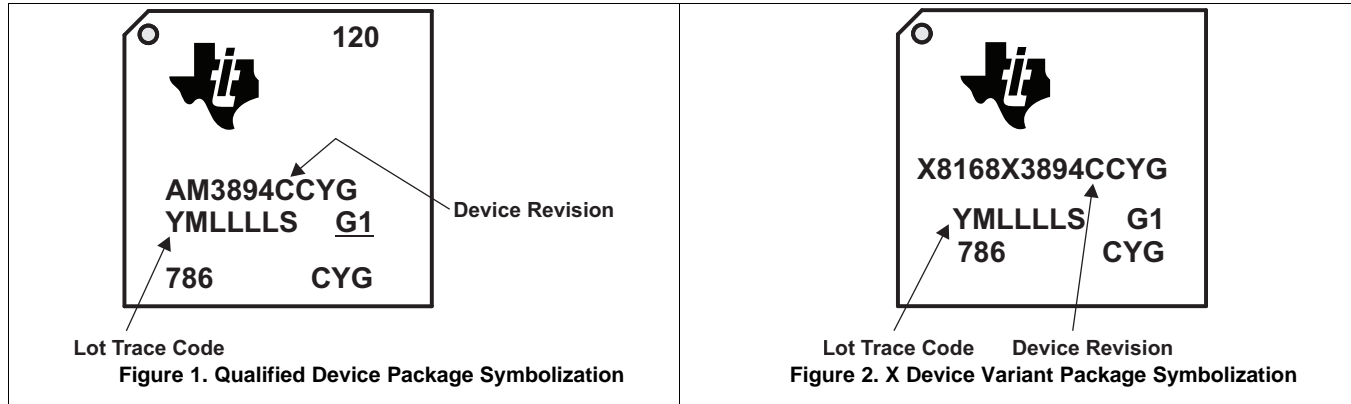
Figure 1 shows an example of the AM389x processor qualified device package symbolization. For X variants of this device, the symbolization shown in Figure 2 is used. The device revision can be identified by the markings on the top of the CYG package; the "C" between the device number and the package identifier indicates the device revision (2.1), as noted in the figures.
