*TMS320DM335*  
*Digital Media System-on-Chip (DMSoC)*  
**Silicon Revision 1.1, 1.3, and 1.4**

## **Silicon Errata**

Literature Number: SPRZ287B  
July 2008—Revised June 2010

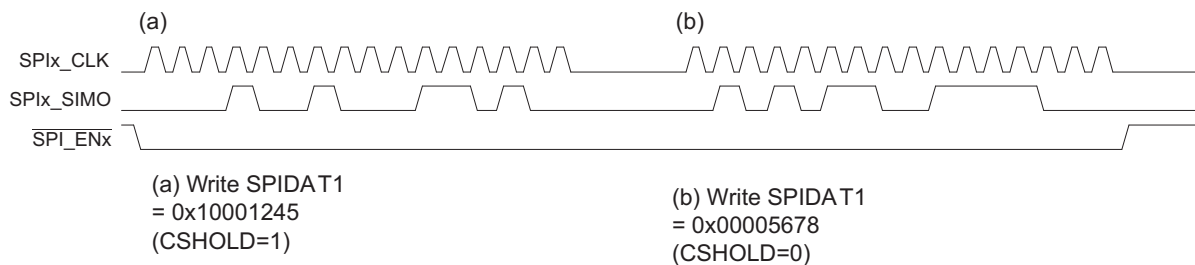
**Figure 7. Expected CSHOLD Behavior**

According to the SPI specification, the following sequence should produce the expected result as illustrated in Figure 7:

- Write 0x10001234 to SPIDAT1 for transmission of 0x1234 (CSHOLD = 1)
- Write 0x00005678 to SPIDAT1 for transmission of 0x5678 (CSHOLD = 0)

Instead, what actually occurs is that  $\overline{\text{SPI\_ENx}}$  is momentarily de-asserted at the beginning of the second write, as illustrated in Figure 8.

Both Figure 7 and Figure 8 assume that SPIDAT1 is written using a single 32-bit write instruction. If SPIDAT1 is instead written using an 8-bit or 16-bit instruction to write to the CSHOLD field, followed by a 16-bit write to the transmit shift register field of SPIDAT1, then what actually occurs is illustrated in Figure 9. This is the same case illustrated in Figure 8 except that the de-assertion of SPI\_ENx lasts for the duration between writing a '0' to the CSHOLD field and writing new data to the transmit shift register.
