Errata

J784S4 AM69x TDA4VH TDA4AH TDA4VP TDA4AP J742S2 AM69x-27 TDA4VPE TDA4APE Processors Silicon Revision 1.0

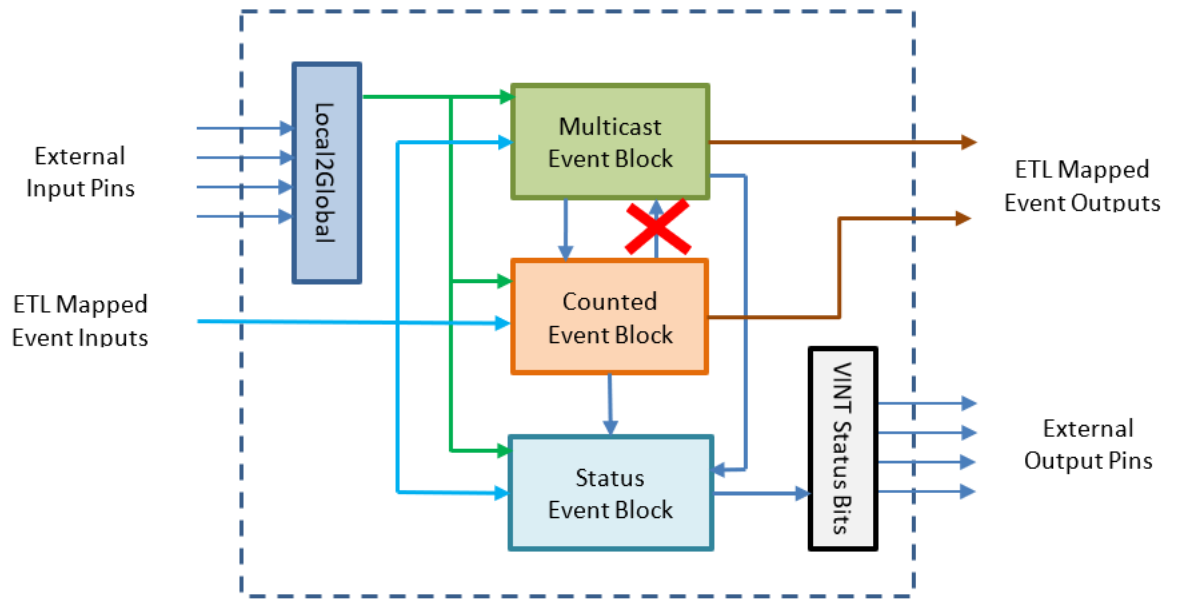
Figure 3-3. Interrupt Aggregator Version 1.0

[Figure 3-3](#) shows the conceptual block diagram of IA 1.0. Potential loops are avoided by adopting the policy of not allowing the counted event block to send events to the multicast block. This method was chosen because it is more common to split an event first, and then count one while sending the other elsewhere. With this path blocked by convention, it is not possible for a single event to visit any block more than once and thus not possible for paths to become blocked so long as the outputs remain unblocked.

i2196 (continued) IA: Potential deadlock scenarios in IA

By following the conventions outlined here, the system is safe from looping hazards that can create a deadlock scenario.
