# CC2652PSIP SimpleLink™ Wireless MCU Device Revision F

This document describes the known exceptions to functional specifications (advisories) to the CC2652PSIP SimpleLink™ device.

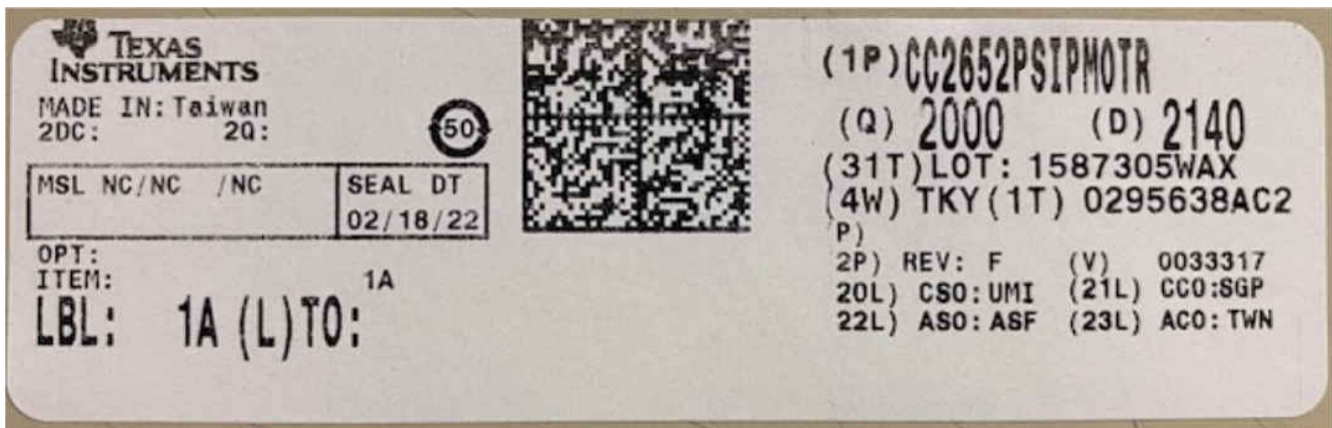
**Figure 2-3. Sample Product Shipping Label for the CC2652PSIP Module**

2. Package label:
  - The die revision name is shown on the tape and reel label as shown in the example label in [Figure 2-3](#).
  - Entry (2P) lists the revision F.
