Errata

MSP430F6775 Microcontroller

This document describes the known exceptions to the functional specifications (advisories).

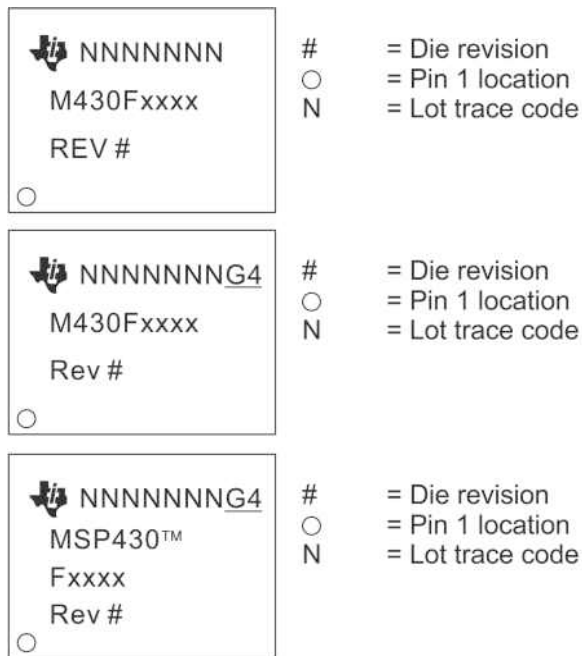
PZ100

LQFP (PZ) 100 Pin

NOTE: Package marking with "TM" applies only to devices released after 2011.
