## ABSTRACT

This document describes the known exceptions to the functional specifications (advisories).

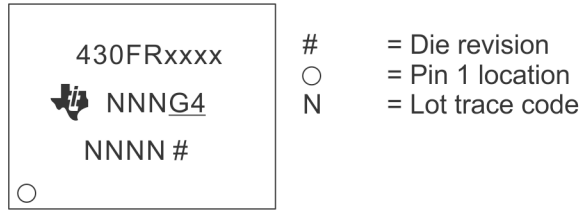
**PT48**
**LQFP (TP), 48 Pin**

# = Die revision  
○ = Pin 1 location  
N = Lot trace code
