Errata
MSP430F67761 Microcontroller

This document describes the known exceptions to the functional specifications (advisories).

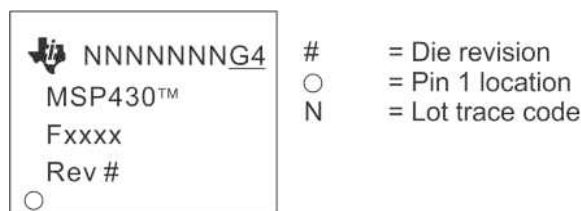
PEU128

QFP (PEU), 128 Pin
