ABSTRACT

This document describes the known exceptions to the functional specifications (advisories).

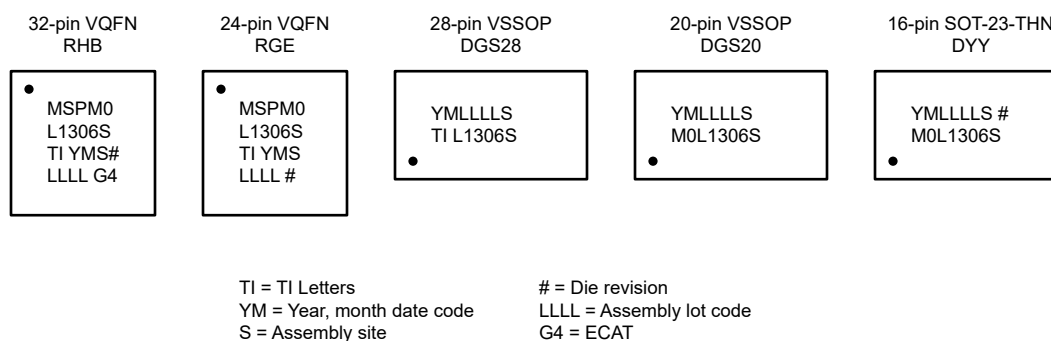
Figure 5-1. Package Symbolization

The package diagrams below indicate the package symbolization scheme, and [Table 5-1](#) defines the device revision to version ID mapping.
