TMS320VC5409A
Digital Signal Processor
Silicon Errata

SPRZ186C
June 2001
Revised May 2003

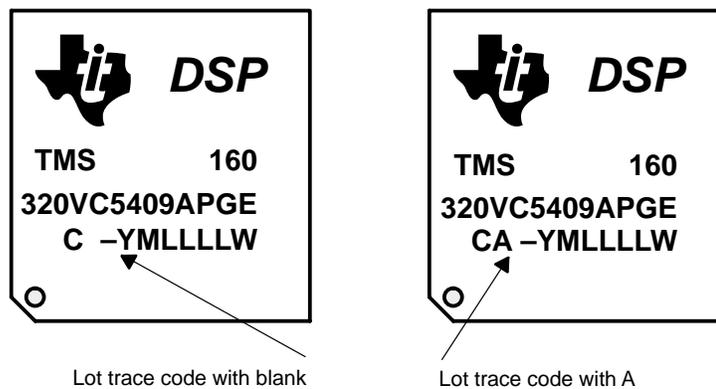
Figure 1. Example, Typical Lot Trace Code for TMS320VC5409A DSP (PGE)

The device revision can be determined by the lot trace code marked on the top of the package. The locations for the lot trace codes for the PGE and the GGU packages are shown in Figure 1 and Figure 2, respectively.

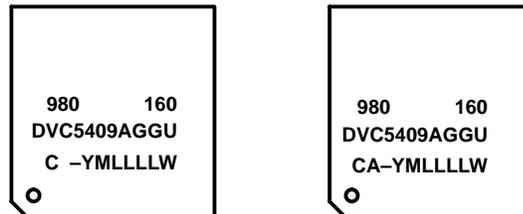
NOTE: Qualified devices in the PGE package are marked with the letters “TMS” at the beginning of the device name, while nonqualified devices in the PGE package are marked with the letters “TMX” or “TMP” at the beginning of the device name. Similarly, qualified devices in the GGU package are marked with the letters “DV” at the beginning of the device name, and nonqualified devices in the GGU package are marked with the letters “XDV” or “PDV” at the beginning of the device name.

Figure 2. Example, Typical Lot Trace Code for TMS320VC5409A DSP (GGU)
