TMS320C6418
Digital Signal Processor
Silicon Errata

Silicon Revision 1.1

SPRZ224A
August 2004
Revised November 2004

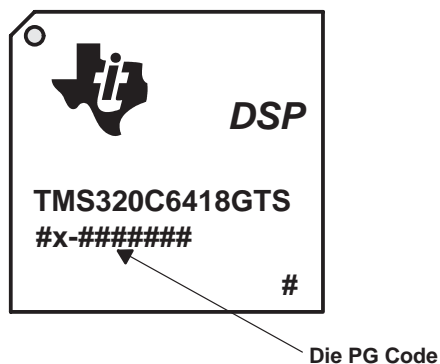
Figure 1. Example, Die PG Codes for TMS320C6418 (GTS)

The device revision can be determined by the Die PG code marked on the top of the package. The location of the Die PG code for the GTS package is shown in Figure 1. Figure 1 shows some examples of the types of C6418 package symbolization.

- NOTES: A. Qualified devices are marked with the letters “TMS” at the beginning of the device name, while nonqualified devices are marked with the letters “TMX” or “TMP” at the beginning of the device name.
 B. “#” denotes an alphanumeric character. “x” denotes an alpha character only.
