# Errata

## MSP430F6776 Microcontroller

This document describes the known exceptions to the functional specifications (advisories).

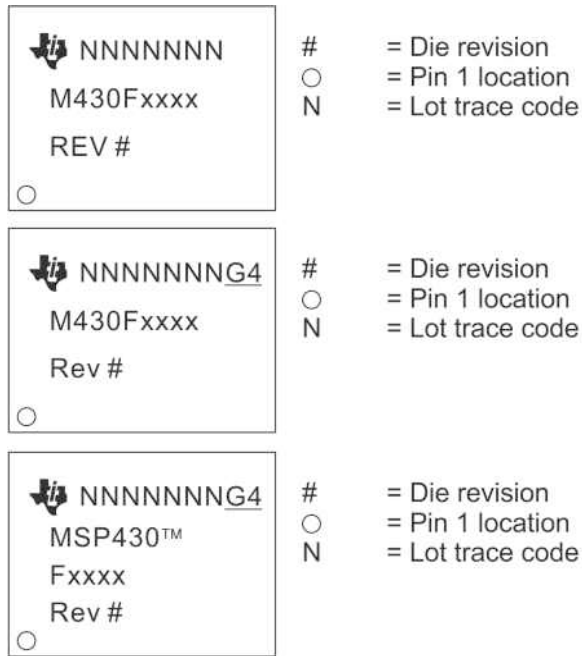
**PZ100**

**LQFP (PZ) 100 Pin**

NOTE: Package marking with "TM" applies only to devices released after 2011.
