TMS320VC5416
Digital Signal Processor
Silicon Errata

SPRZ172F
April 2000
Revised January 2006

This document describes the silicon updates to the functional specifications for the TMS320VC5416 silicon. The errata are applicable to:

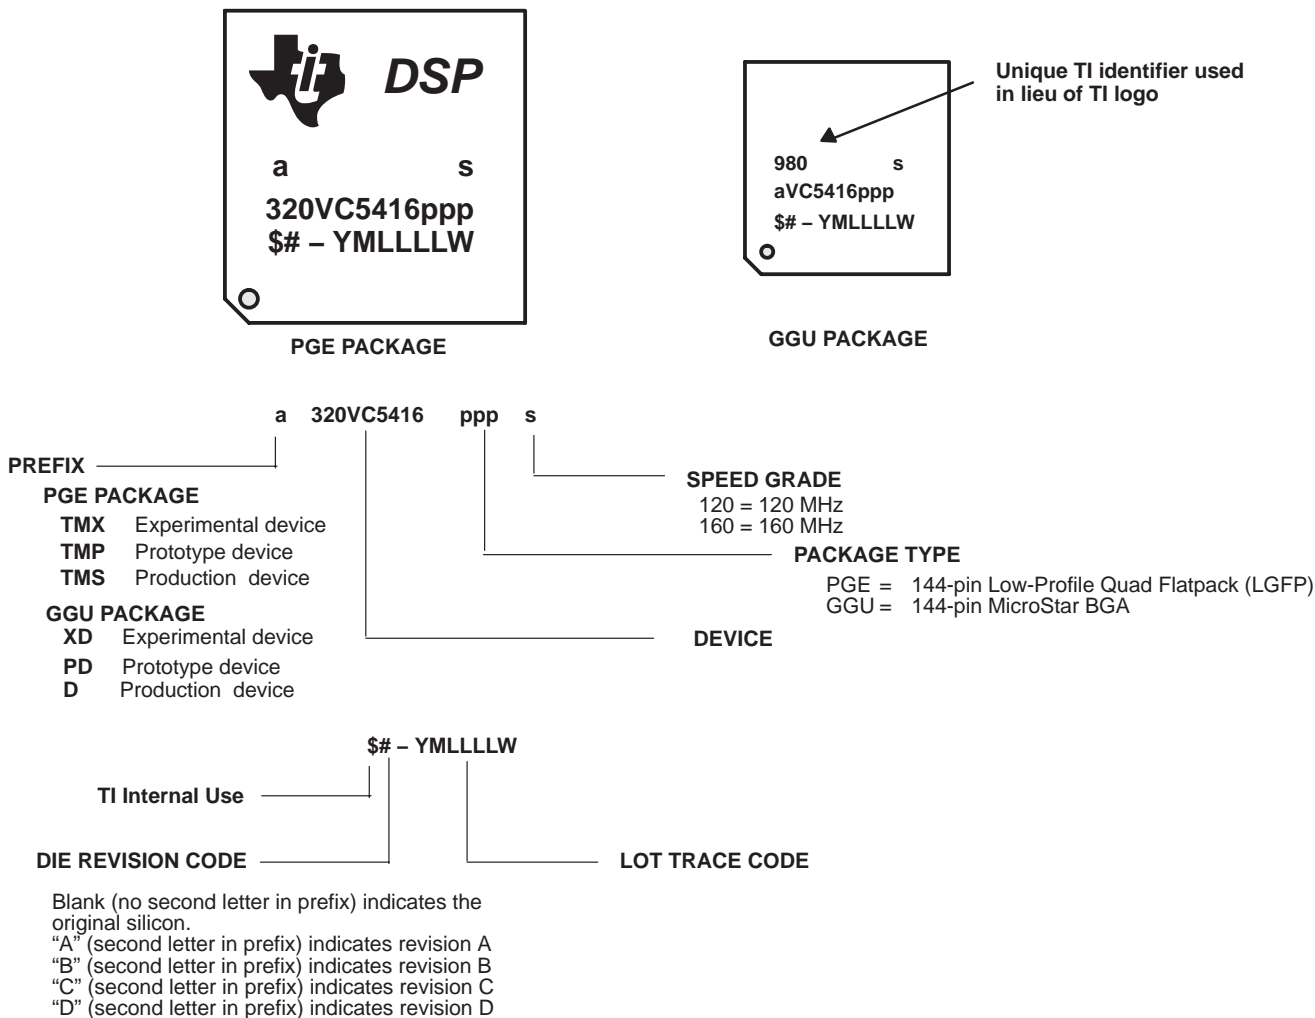
Figure 1 provides an example of the 5416 device markings and defines each of the markings. The device revision can be determined by the symbols marked on the top of the package as shown in Figure 1. Some prototype devices may have markings different from those illustrated.

Figure 1. Example Markings for 5416 Packages
