# CC2652RSIP SimpleLink™ Wireless MCU Device Revision F

This document describes the known exceptions to functional specifications (advisories) to the CC2652RSIP SimpleLink™ device.

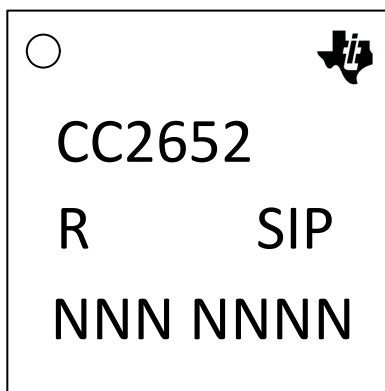
Figure 2-1. Package Symbolization

Figure 2-1 and Table 2-1 describe package symbolization and the device revision code.
