BGA Package Component Reliability After Long-Term Storage

ABSTRACT

This paper provides additional data in support of shelf life extension for BGA and Die Size BGA (DSBGA) Packages.

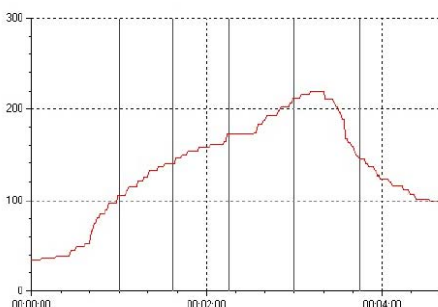
Figure 1. Reflow Profile for SnPb Solder Paste

The following profiles show the temperature during the soldering process on a test board. Temperature measured on the package.

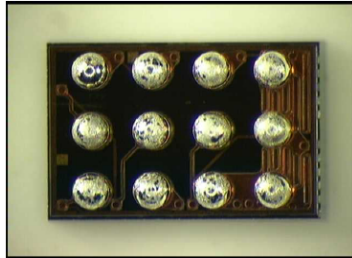
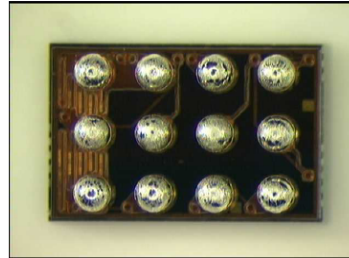
Bottom view – Units not soldered

Figure 3. Virgin Unit

Figure 4. Unit After Steam Aging

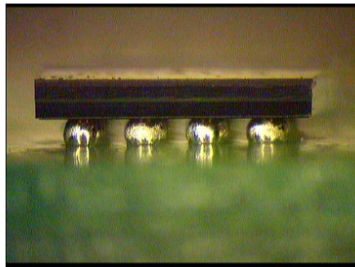
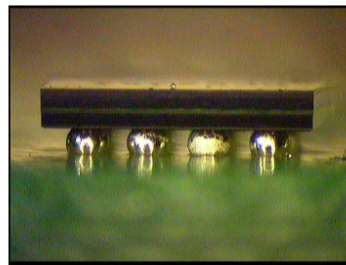
Units placed on Test Board #45. SnAgCu solder paste for lead-free balls, peak temperature 240°C

Figure 5. Virgin Unit

Figure 6. Steam Aging

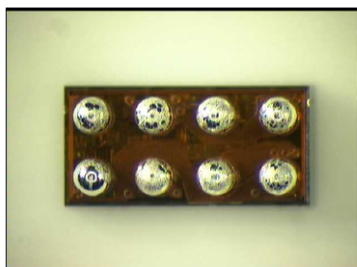
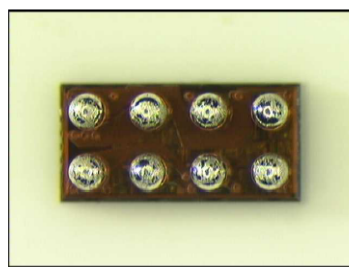
Bottom view – Units not soldered

Figure 9. Virgin Unit

Figure 10. Unit After Steam Aging

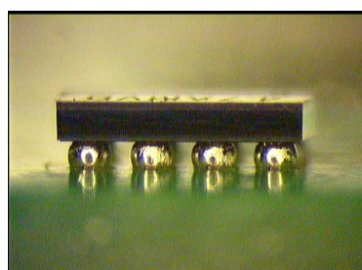
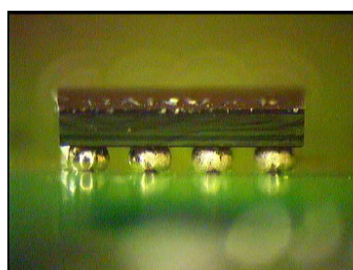
Units placed on Test Board #45. SnAgCu solder paste for lead-free balls, peak temperature 240°C

Figure 11. Virgin Unit

Figure 12. Steam Aging

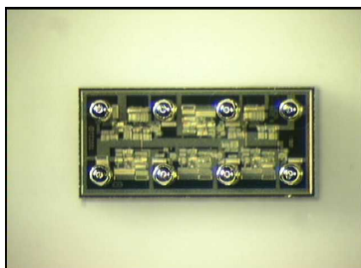
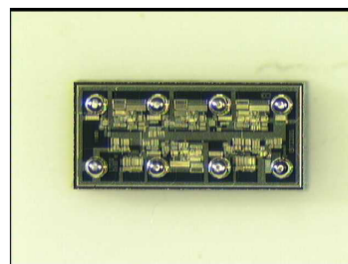
Bottom view – Units not soldered

Figure 15. Virgin Unit

Figure 16. Unit After Steam-Aging

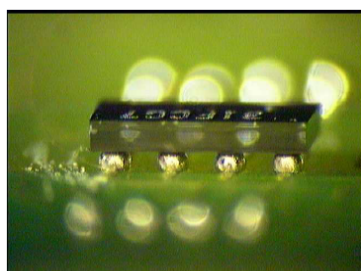
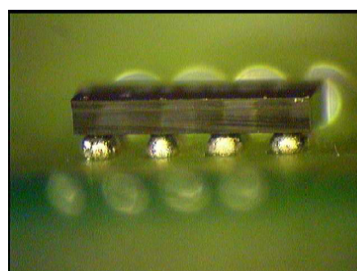
Units placed on Test Board #41. SnAgCu solder paste for lead-free balls, peak temperature 240°C

Figure 17. Virgin Unit

Figure 18. Steam-Aging

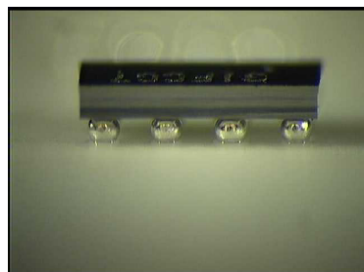
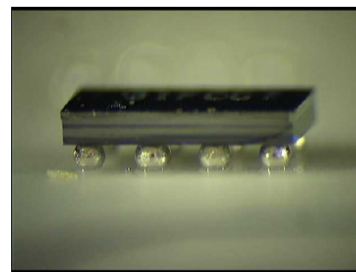
Units placed on ceramic plate. SnAgCu solder paste for lead free balls, peak temperature 240°C

Figure 19. Virgin Unit

Figure 20. Steam-Aging

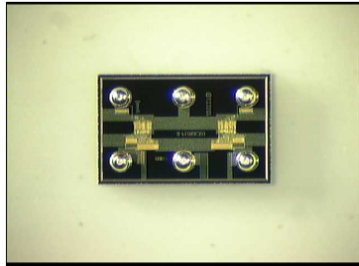
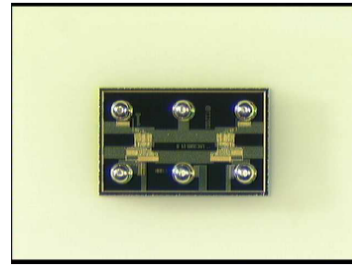
Bottom view – Units not soldered

Figure 21. Virgin Unit

Figure 22. Unit After Steam-Aging

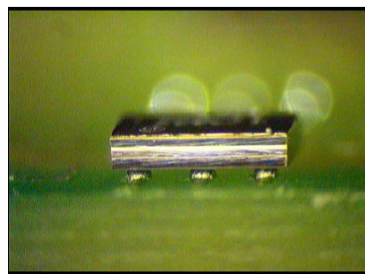
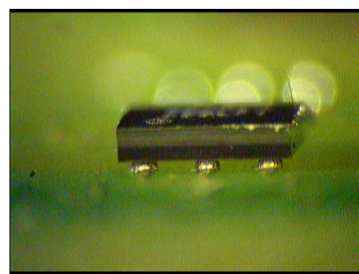
Units placed on Test Board #41. SnPb solder paste for non lead-free balls, peak temperature 220°C

Figure 23. Virgin Unit

Figure 24. Steam-Aging

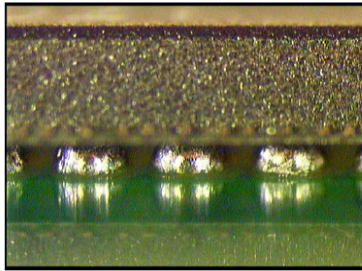
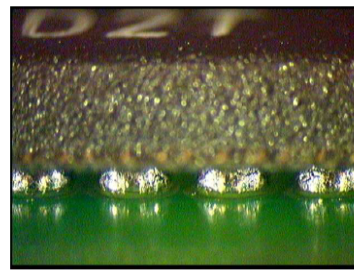
Units placed on Test Board #56. SnPb solder paste for non lead-free balls, peak temperature 220°C

Figure 35. Virgin Unit

Figure 36. Steam-Aging

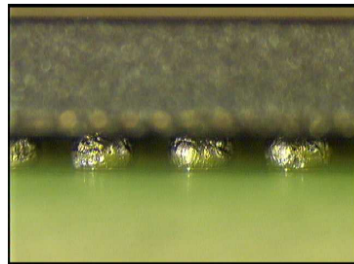
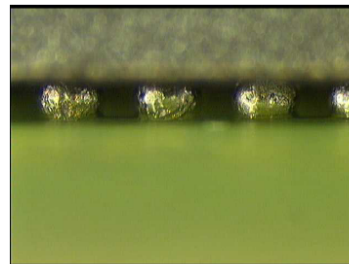
Units placed on Test Board #40. SnPb solder paste for non lead-free balls, peak temperature 220°C

Figure 47. Virgin Unit

Figure 48. Steam-Aging

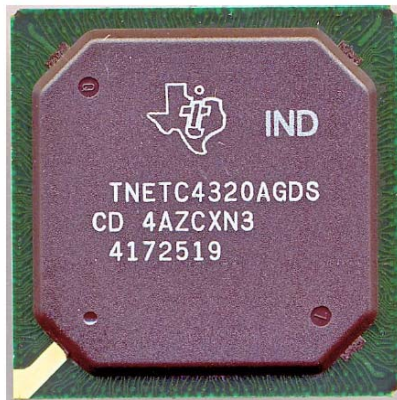
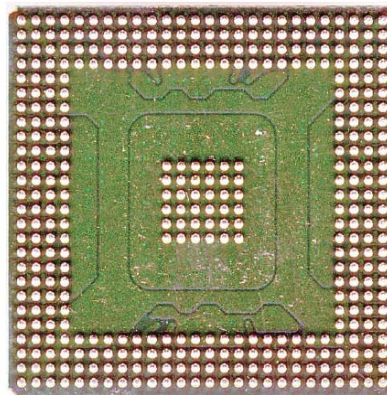
Microscopic image of large BGA package not soldered. Manufactured: 2004
DPA performed at TI Tucson

Figure 51. Virgin Unit

Figure 52. Virgin Unit, Bottom View

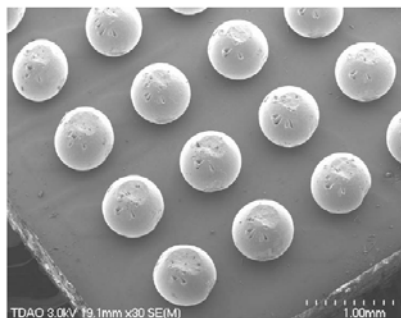
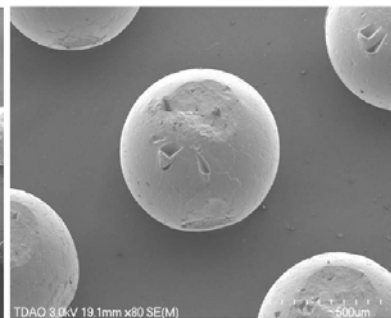
Field Emission Scanning Electron Microscopy (FESEM) Micrograph of representative TNETC4320AGDS device solder balls.

Figure 53. Image of Solder Balls

Figure 54. Detailed View

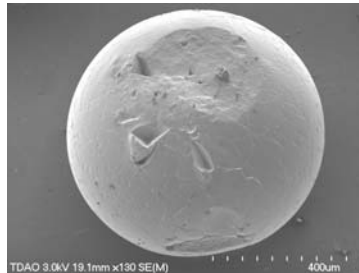
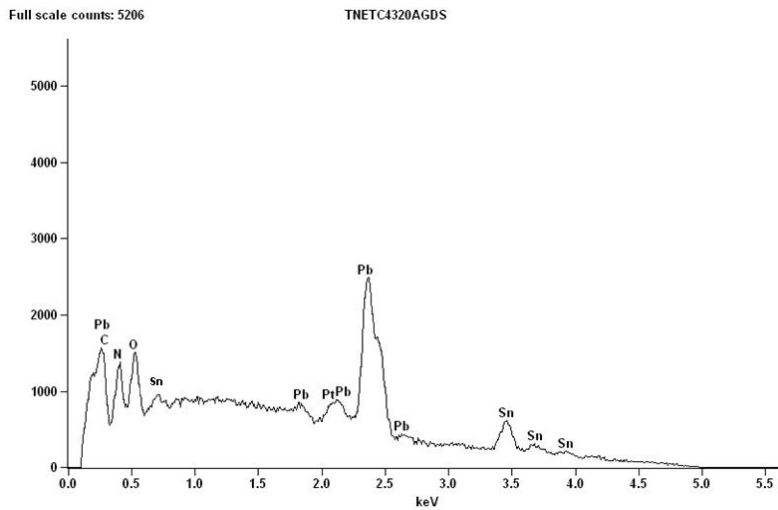
FESEM Micrograph and Energy-Dispersive Spectroscopy (EDS) spectrum of representative TNETC4320AGDS device solder ball.

Figure 55. Detailed Image of Solder Ball

Figure 56. Element Analysis of the Solder Ball

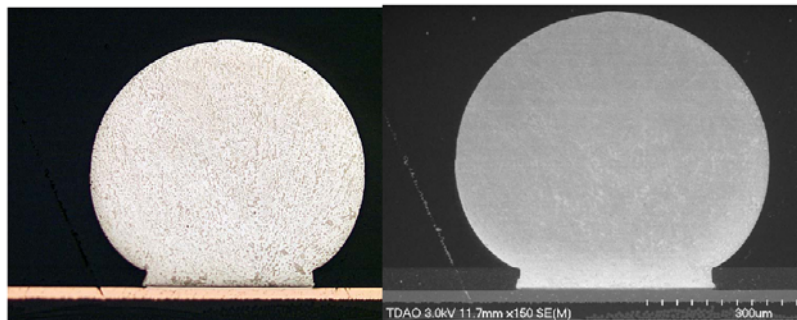
Optical and FESEM micrograph of a representative TNETC4320AGDS device solder ball cross-section. No abnormalities were observed.

Figure 57 Microscopic View Figure 58. FESEM Image of Solder Ball Cross-section

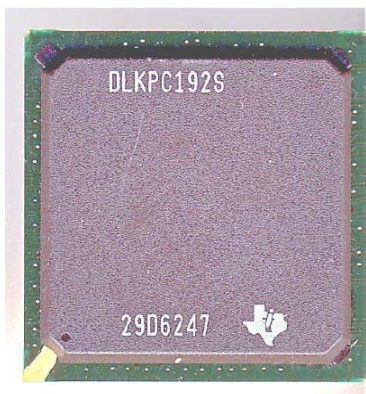
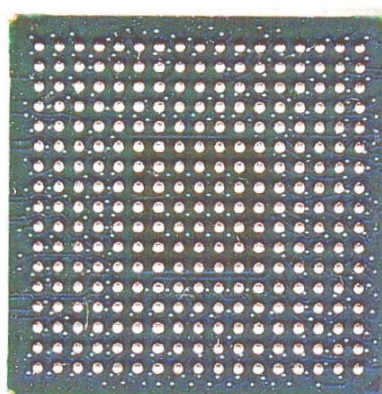
Microscopic image on large BGA package not soldered. Manufactured: 2002

Figure 59. Virgin Unit

Figure 60. Virgin Unit - Bottom View

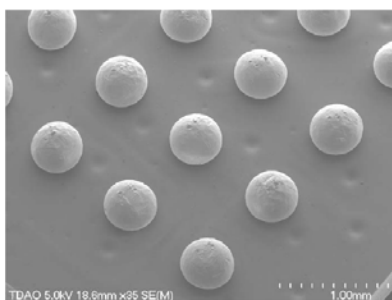
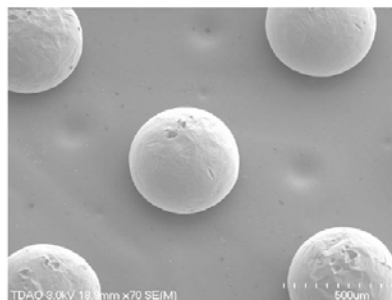
FESEM micrograph of representative DLKPC192S device solder balls.

Figure 61. Solder Ball View

Figure 62. Detailed View

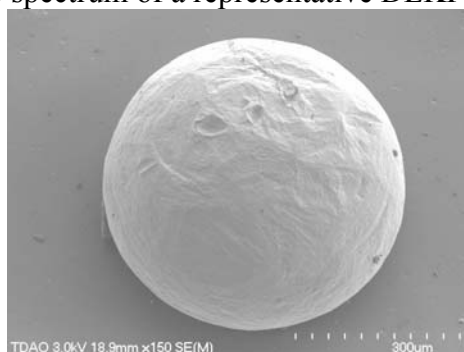
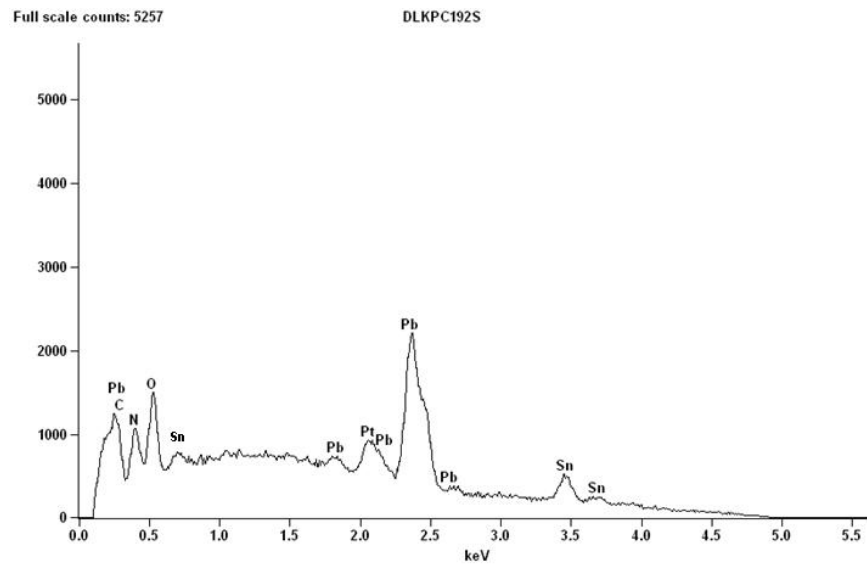
FESEM micrograph and EDS spectrum of a representative DLKPC192S device solder ball.

Figure 63. Solder Ball Detailed View

Figure 64. Element Analysis of the Solder Ball

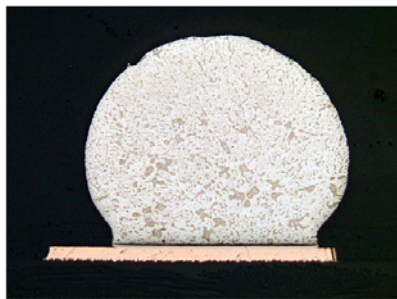
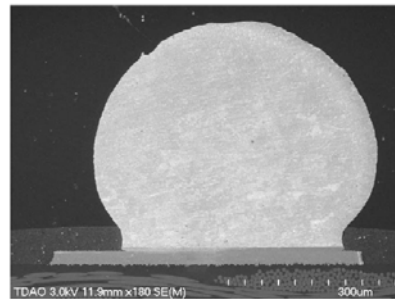
Optical micrograph and FESEM micrograph of a representative DLKPC192S device solder balls.

Figure 65. Microscopic View

Figure 66. FESEM Image of Solder Ball Cross-section

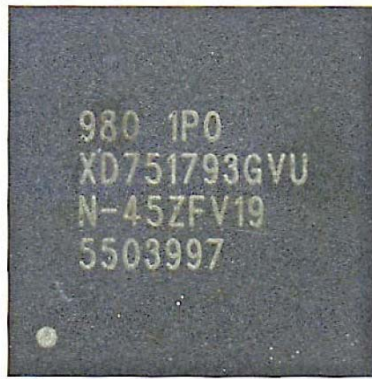
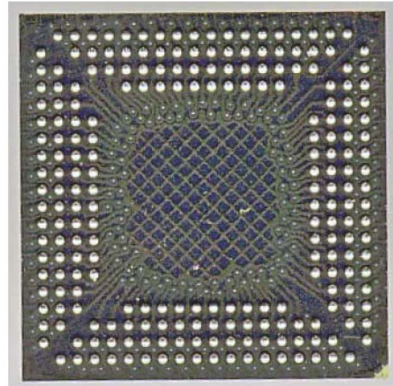
Microscopic image of large BGA package not soldered. Manufactured: 2004

Figure 67. Virgin Unit

Figure 68. Virgin Unit - Bottom View

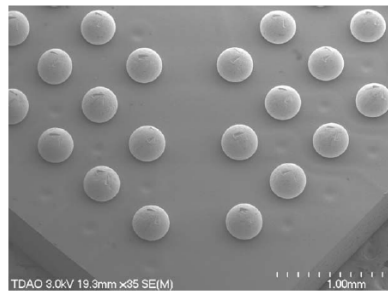
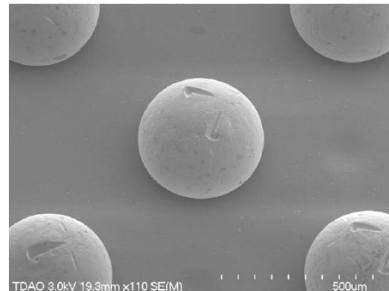
FESEM micrograph of representative XD751793GVU device solder balls.

Figure 69. Image of Solder Balls

Figure 70. Detailed View

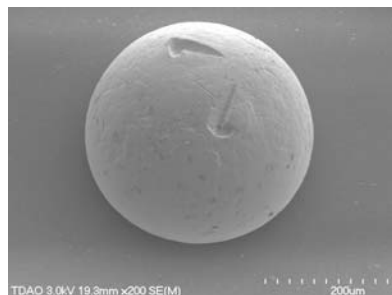
Figure 71. Detailed View - The visible scratches on the ball surface are from the electrical test socket contractor.

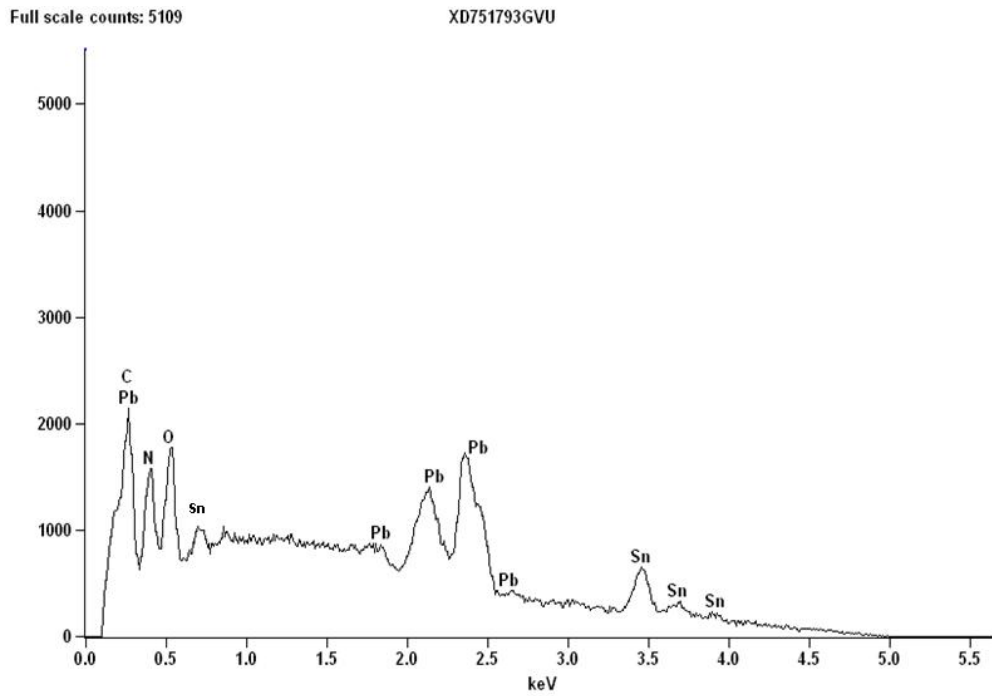
EDS spectrum of a representative XD751793GVU device solder ball.

Figure 72. Element Analysis of the Solder Ball

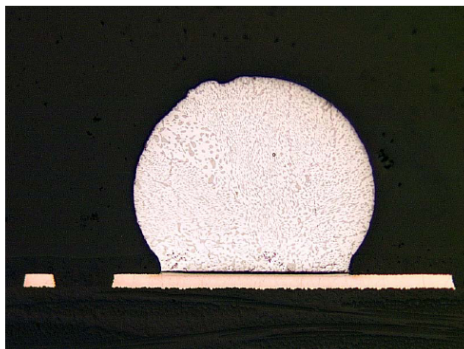
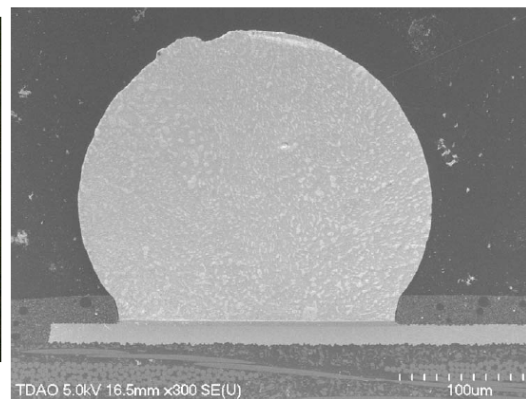
Optical and FESEM micrograph of a representative XD751793GVU device solder ball cross-section.

Figure 73. Microscopic View

Figure 74. FESEM Image View

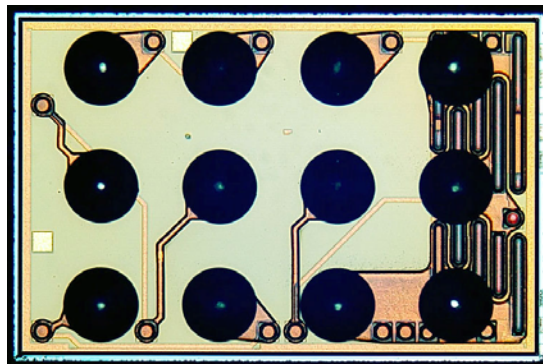
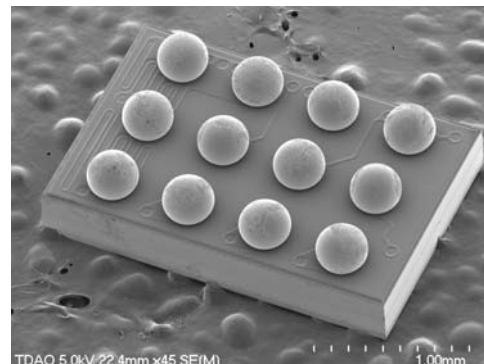
Microscopic image of the investigated DSBGA package – Lead-free solder ball composition.
Manufactured: June 2005

Figure 75. Microscopic View

Figure 76. FESEM Image View

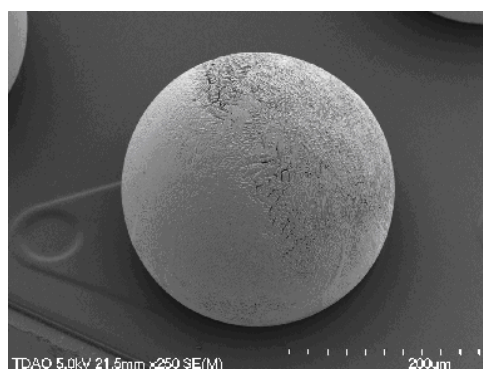
FESEM micrograph of representative TPSDC6235YZG device solder ball

Figure 77. Detailed View of Solder Ball

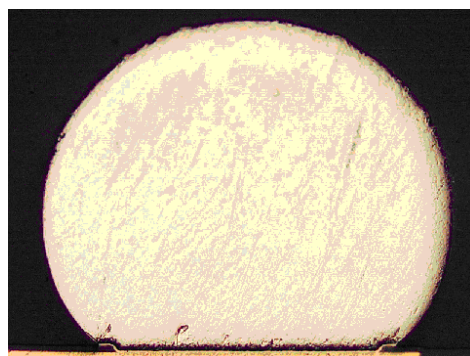
Microscopic view of TPSDC6235YZG cross-section

Figure 78. Solder Ball Cross-section View

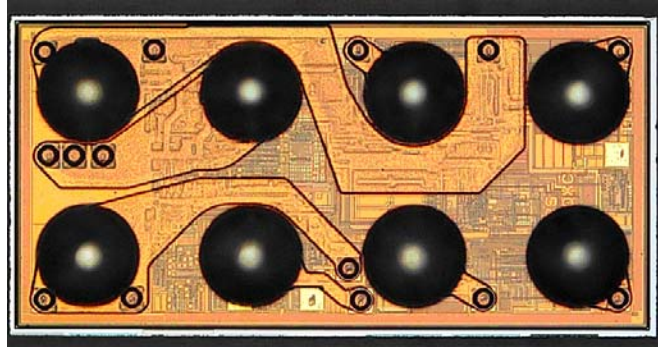
Microscopic image of the investigated DSBGA package – Lead-free solder ball composition.
Manufactured: April 2007

Figure 79. Microscopic View

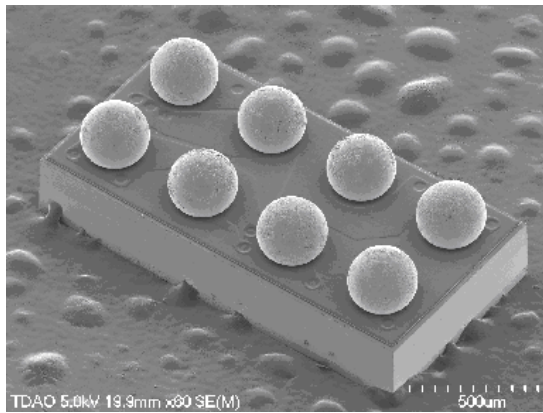
FESEM micrograph of representative TPS62302YZD device solder balls

Figure 80. FESEM Image View

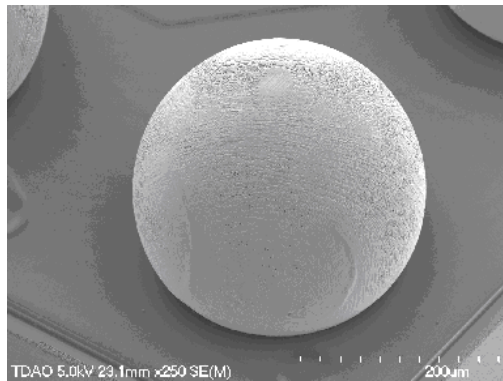
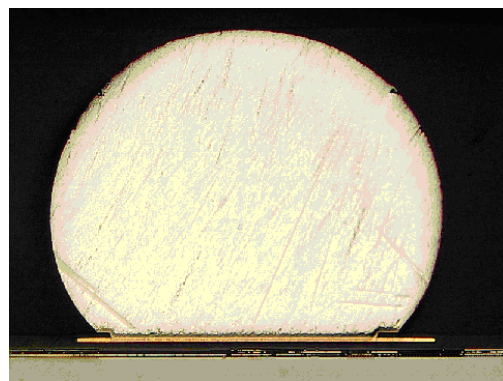
FESEM view of TPS62302 and Optical microscope cross-section

Figure 81. FESEM Image View

Figure 82. Solder Ball Cross-section View
